THE BELL TOWER INCIDENT AT SIGOLSHEIM

**A Very Compelling Evidence for the Failure of the
Early Streamer Emission Technology & Standard.**

By
Z. A. Hartono & I Robiah
September 2010
E-mail: zahartono@ieee.org

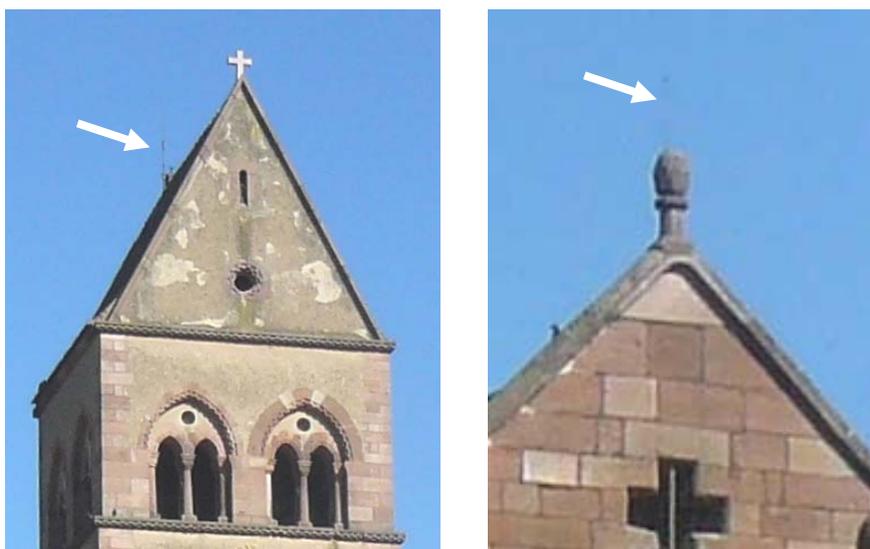
Figure 2: Magnified pictures of the church reveals a Helita Pulsar 25 ESE lightning air terminal (left) and a Franklin air terminal (right) installed on roofs of the bell tower and main hall respectively.

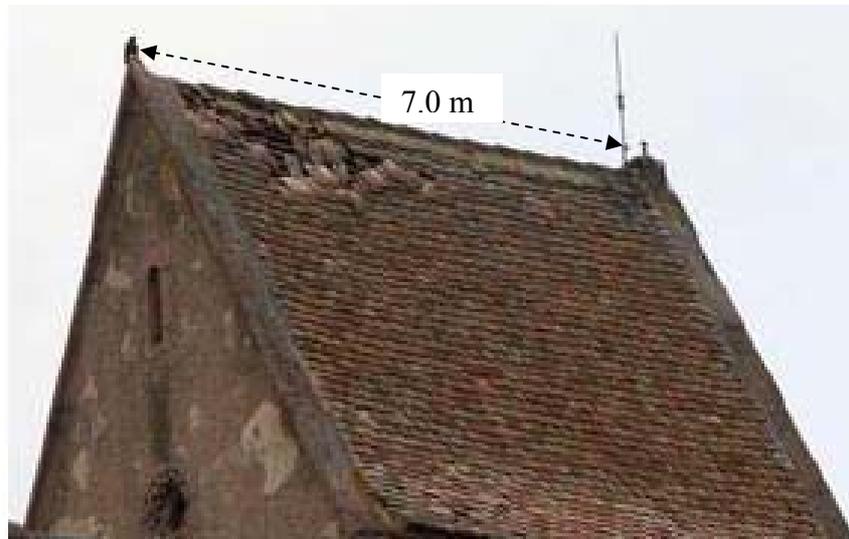
According to the Dernières Nouvelles D'alsace (DNA) News article dated May 29, 2009, lightning had struck the stone cross of the bell tower at 11.20 pm on May 21, 2009. The damaged cross fell through the roof tiles and subsequently damaged the interior of the bell tower (Figure 3). The article also mentioned that the ESE air terminal had been inspected annually and therefore should have been functioning properly at the time of the incident.

Figure 3: The bell tower of the Saint Pierre and Paul church in Sigolsheim soon after the lightning strike incident. The Helita Pulsar 25 ESE air terminal is at the right. (Photo: DNA News)

A study was conducted by the Chambre des Experts Agrées, Communauté Européenne (CEACE) to determine the cause of the lightning strike to the stone cross. The CEACE report no. 8024213399-59 mentioned that the length of the bell tower roof was 7.0 m and the distance between the stone cross and the Helita Pulsar 25 air terminal was less than 6.0 m. The report also mentioned that the tip of the air terminal is 0.9 m higher than the cross and that the air terminal did not exhibit any signs of lightning interception. This suggests that the air terminal had never been struck by lightning before the May 2009 event.

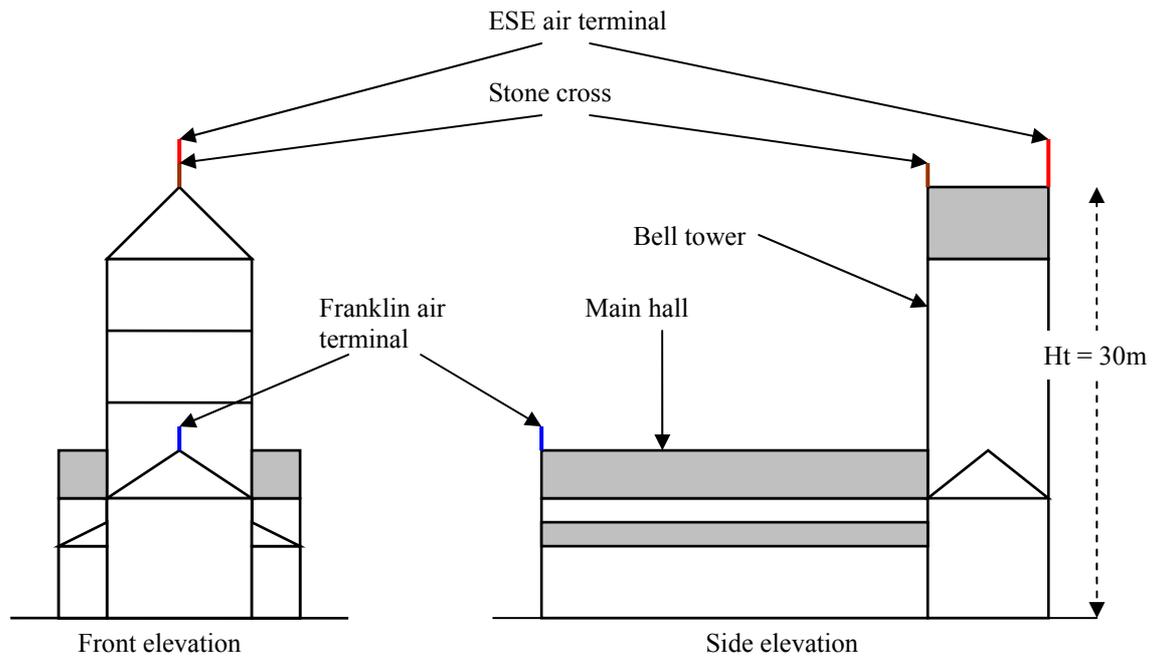
The dimensions of the church and bell tower were critical in evaluating the failure of the ESE air terminal. It was estimated that the height of the bell tower is approximately 30 m, which is much lower than the tall office, hotel and apartment buildings in Malaysia that were installed with the ESE air terminals (Figure 4).

Figure 4: Graphic representation of the Saint Pierre and Paul church.

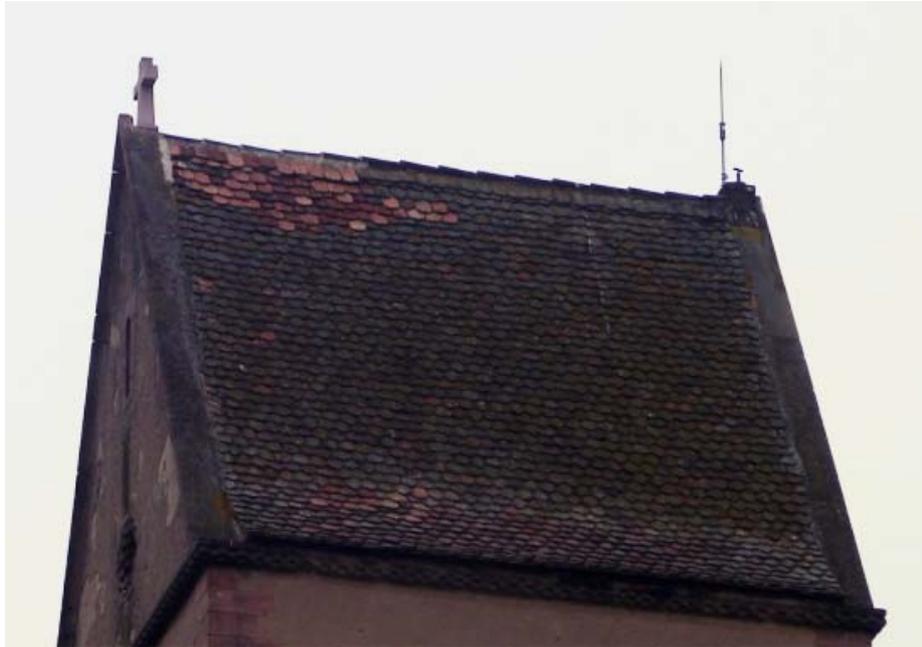
The original design of the ESE air terminal seemed to be according to the ESE standard since the manufacturer or contractor did not make any change to it. This can be seen from the fact that the height of the air terminal was the same after the bell tower had been repaired and a new stone cross installed (Figure 5).

Figure 5: The repaired bell tower of the Saint Pierre and Paul church in Sigolsheim taken a year after the lightning strike incident. Note the new stone cross and the absence of any change in the height of the ESE air terminal.

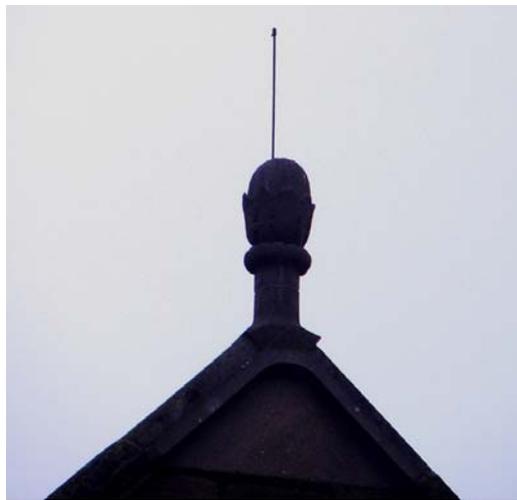
The position of the blunt tipped Franklin rod on the main hall of the Saint Pierre and Paul church complied with the recommendation of the IEC62305 standard (Figure 6). Had the lightning bolt that struck the cross been displaced further away from the bell tower, it may have bypassed the stone cross and struck the Franklin rod instead. If that had been the case, then the lightning strike event at the church would not have resulted in any damage to the roof and credit for protecting the church might have gone to the ESE air terminal instead if the Franklin rod was not inspected in detail for signs of lightning attachment.

Figure 6: Another view of the correctly positioned Franklin rod on top the roof of the main building.

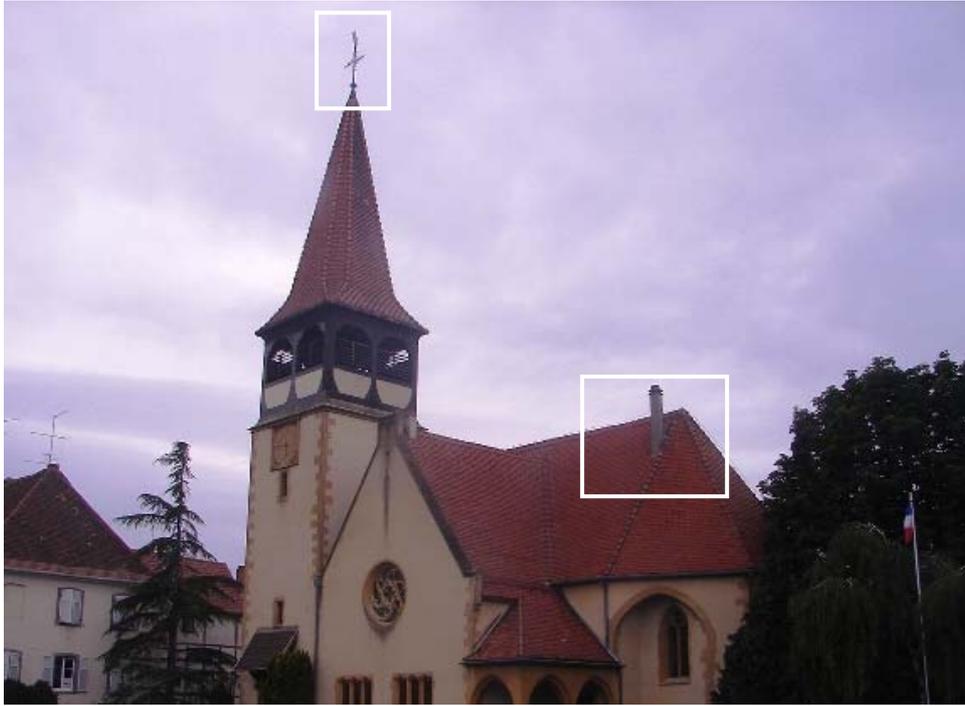
The practice of using both the ESE and conventional air terminals seems to be common in France since this practice was also observed in some other churches as well (Figures 7 and 8). This suggests that hundreds of other churches in France may have been protected in this way. Therefore, it is possible that there could have been other ESE bypass events, similar to that which occurred in Sigolsheim, which may have gone unnoticed especially when the attachment occurred on a correctly positioned conventional air terminal.

Figure 7: Another French church which has been installed with both the ESE and conventional air terminals.

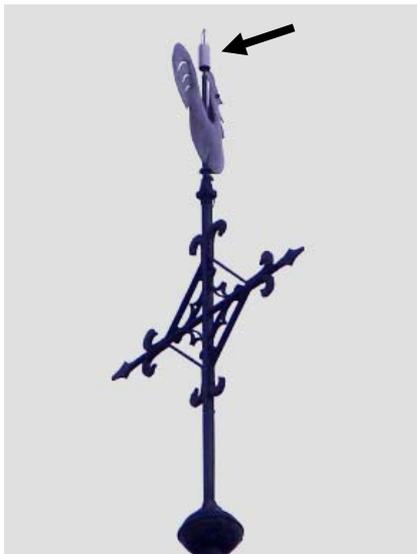
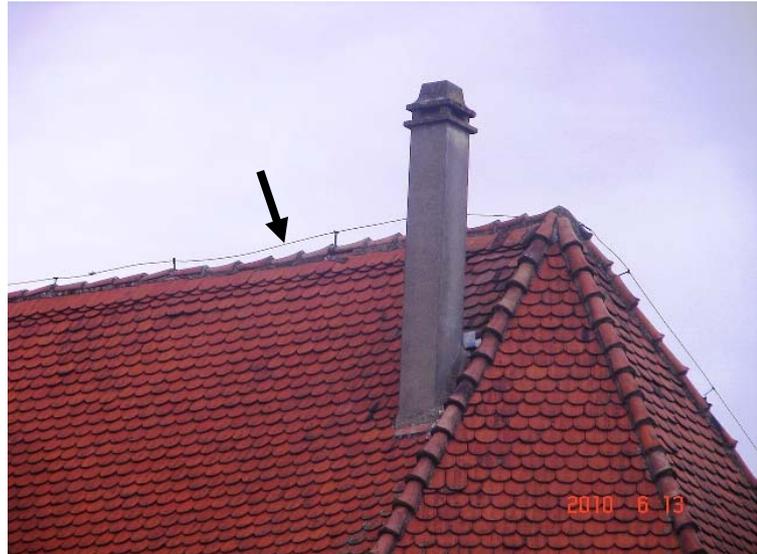
Figure 8: Magnified pictures of the church showing an ESE lightning air terminal (left) and a conventional air terminal (right) installed on the roof.
