CASE STUDIES ON THE COLLECTION VOLUME METHOD

Including comparisons with the ESE standard, NF C 17-102.

By
Z. A. Hartono & I Robiah
Senior Members IEEE
October 2010
E-mail: zahartono@ieee.org

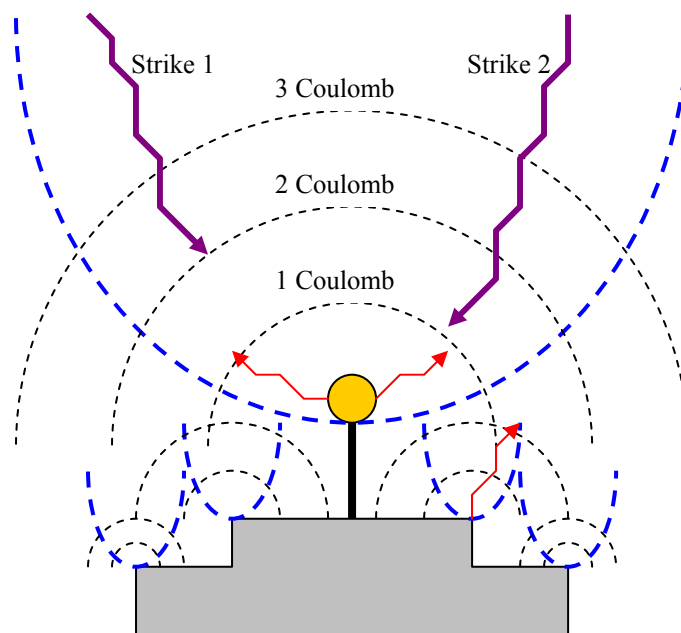
Figure 1: The CVM concept reproduced from a Dynasphere product brochure.

According to a Dynasphere product brochure, the CVM is “*an improved Electro-geometric Model for defining lightning capture areas. This model allows computation of parabolic-like lightning “collection volumes” (shown in blue) for all potential strike points on a structure. The model takes into account many fundamental physical quantities such as structure height, electric field intensification on the approach of a downward leader, leader velocity ratio, downward leader charge and site altitude. It uses the concept of “attractive radius” – the capture radius of the collection volume when viewed in plan. The collection volume assumes all points on a structure are able to launch an intercepting upward leader (shown in red), but differentiates these points based on the field intensification they create as shown in the figure below*”. (See Figs. 1, 2 and 3),

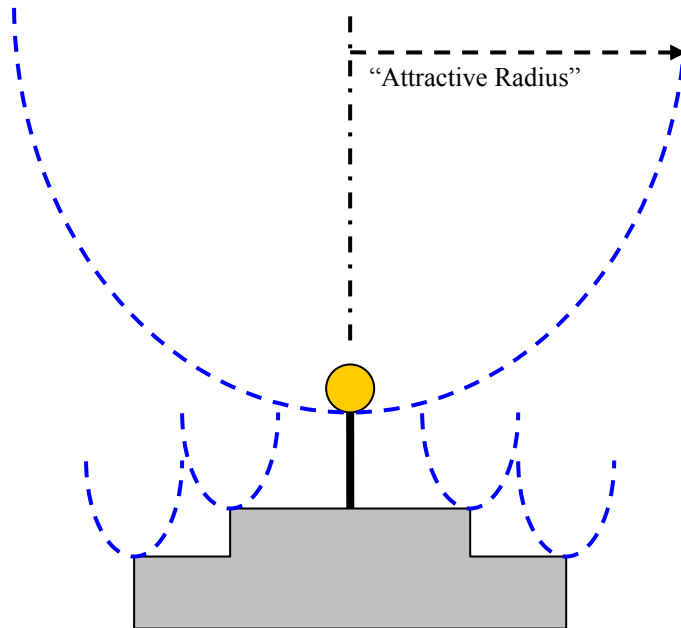
Figure 2: The “attractive radius” of the Dynasphere.

In the graphical description of the CVM, the collection volume of the Dynasphere air terminal (orange ball) is always shown as the biggest of them all since it is claimed that the field intensification at the terminal is the highest. The “attractive radius” of the Dynasphere collection volume, when viewed in plan, is claimed to cover the whole building. Hence, it is claimed that lightning down leaders that descend into the Dynasphere collection volume will be collected at the air terminal instead of at the remote corners of the building.

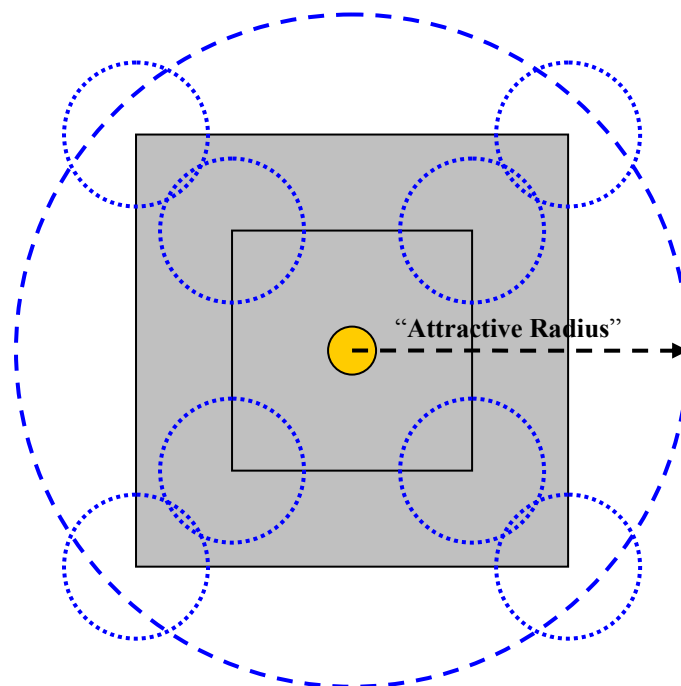
Figure 3: The “attractive radius” of the Dynasphere (when viewed in plan).

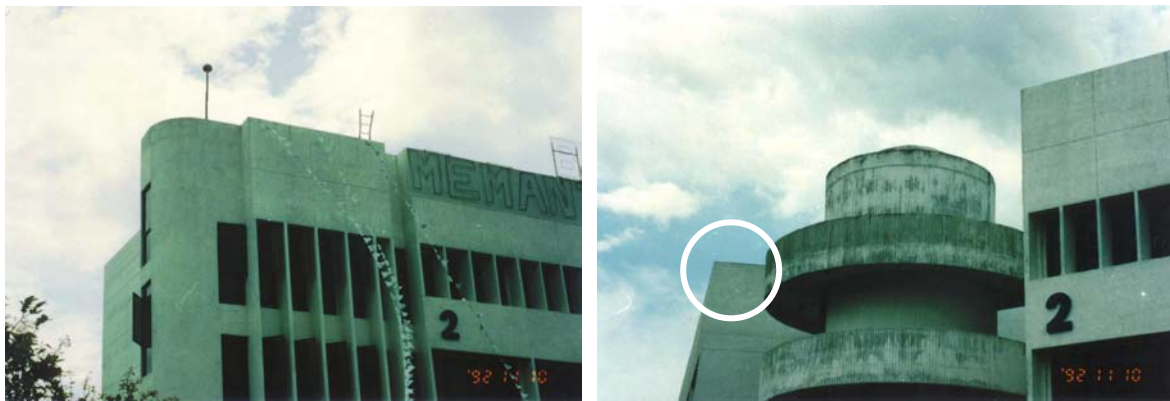
This 20 metre high building was installed with the Dynasphere ESE air terminal in 1991. It is connected to an adjacent building (Building 3) via a circular staircase. Building 3 was also installed with a French made ESE air terminal (Fig. 4).

Figure 4: The Dynasphere on Building 2 (left) and the undamaged roof corner of Building 3 (right) taken in 1992.

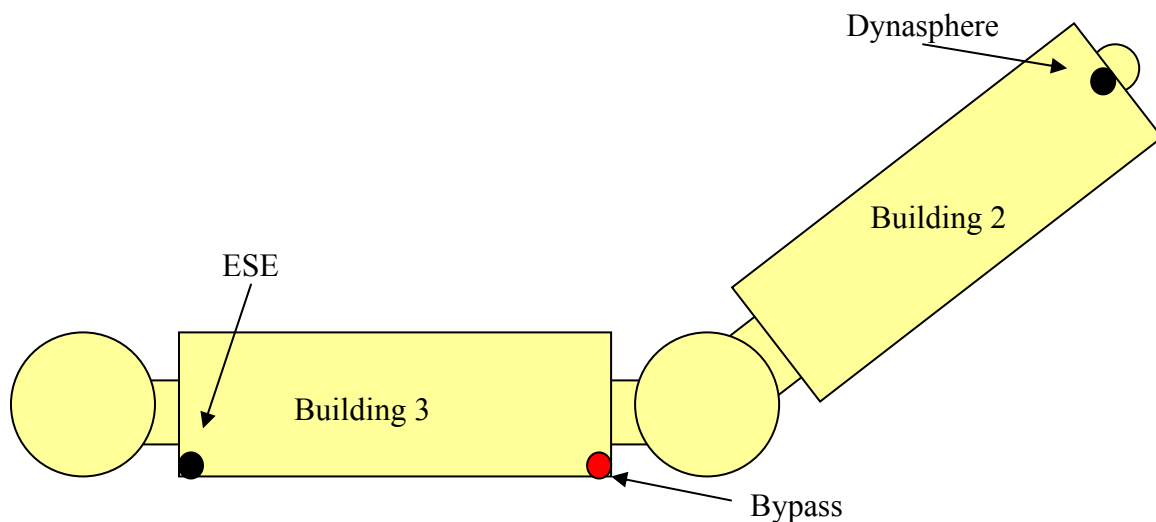
In 1995, a bypass was observed at the upper corner of Building 3 near the staircase. The distance between the bypass and the Dynasphere was about 60 metres i.e. still within the claimed “attractive radius” of the Dynasphere air terminal (Figs. 5, 6 and 7).

Figure 5: Plan view of Buildings 2 and 3 showing the relative positions of the air terminals and the bypass.

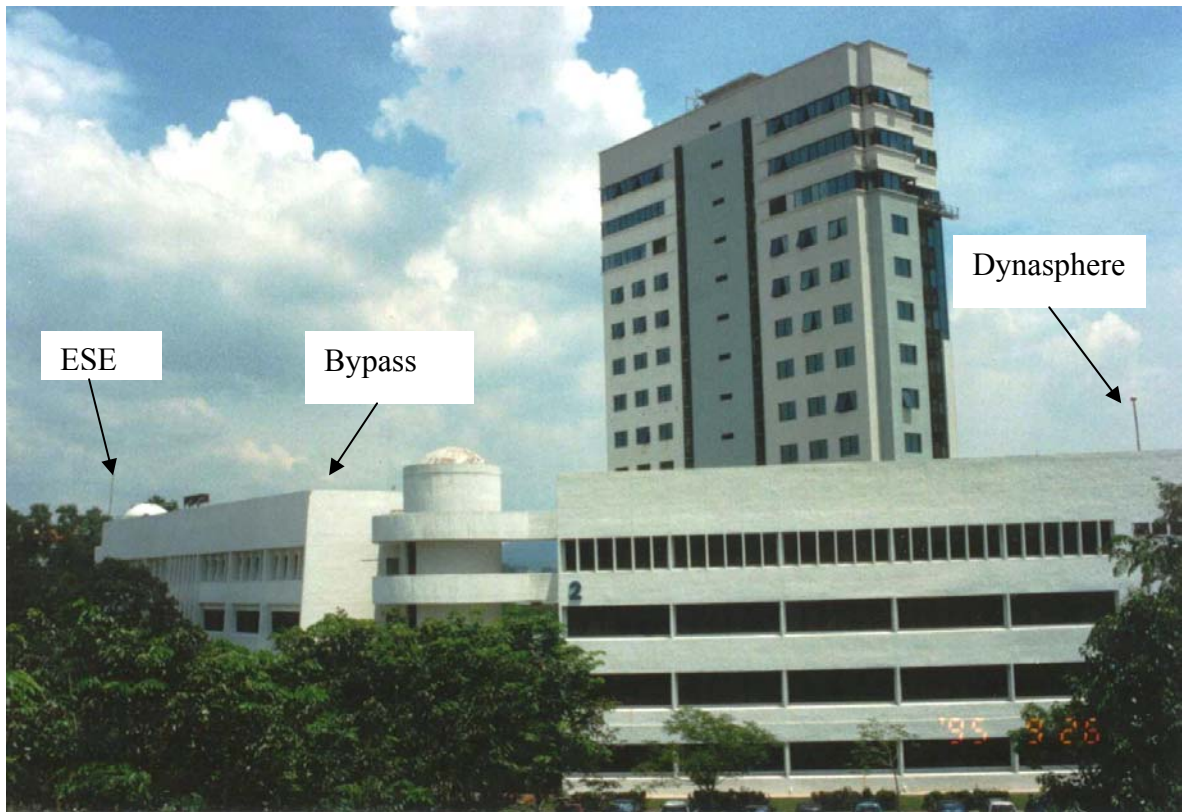
Figure 6: A wide angle photo of buildings 2 and 3 which showed the positions of the Dynasphere and ESE air terminals and the bypass.

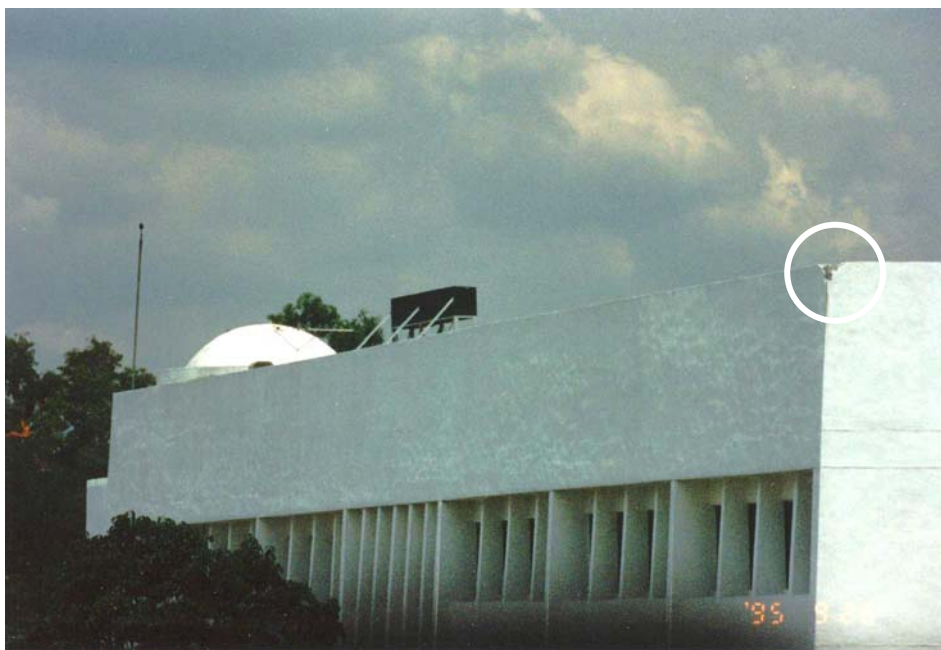
Figure 7: Close-up of the bypass (right) and the ESE air terminal (left) on Building 3.

The SIRIM case study also demonstrated that lightning can bypass both the ESE and Dynasphere air terminals at the same time, hence casting doubts about the validity of the CVM and the ESE standard, NF C 17-102.

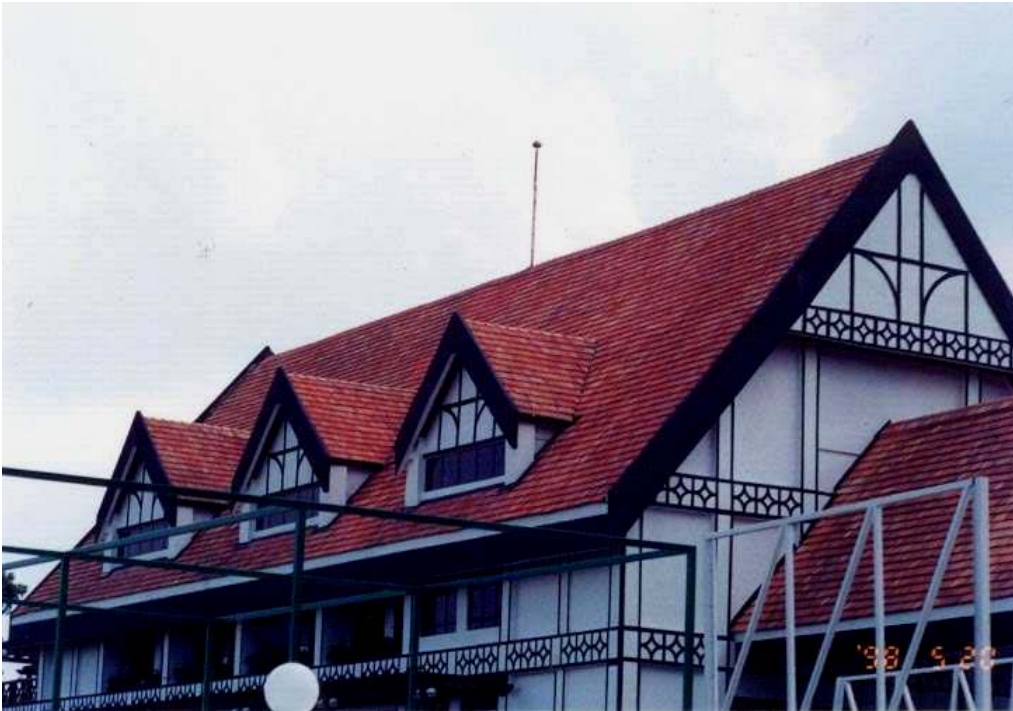
The 25 metre high RSC building was installed with the Dynasphere air terminal at the centre of the roof in February 1998. In May 1998, a small bypass was observed on the rear upper façade of the roof less than 20 metres away from the air terminal. In May 2001, a bigger bypass was observed on the front upper façade (Figs. 8 and 9).

Figure 8: The Dynasphere installed on the roof of the RSC building in 1998.

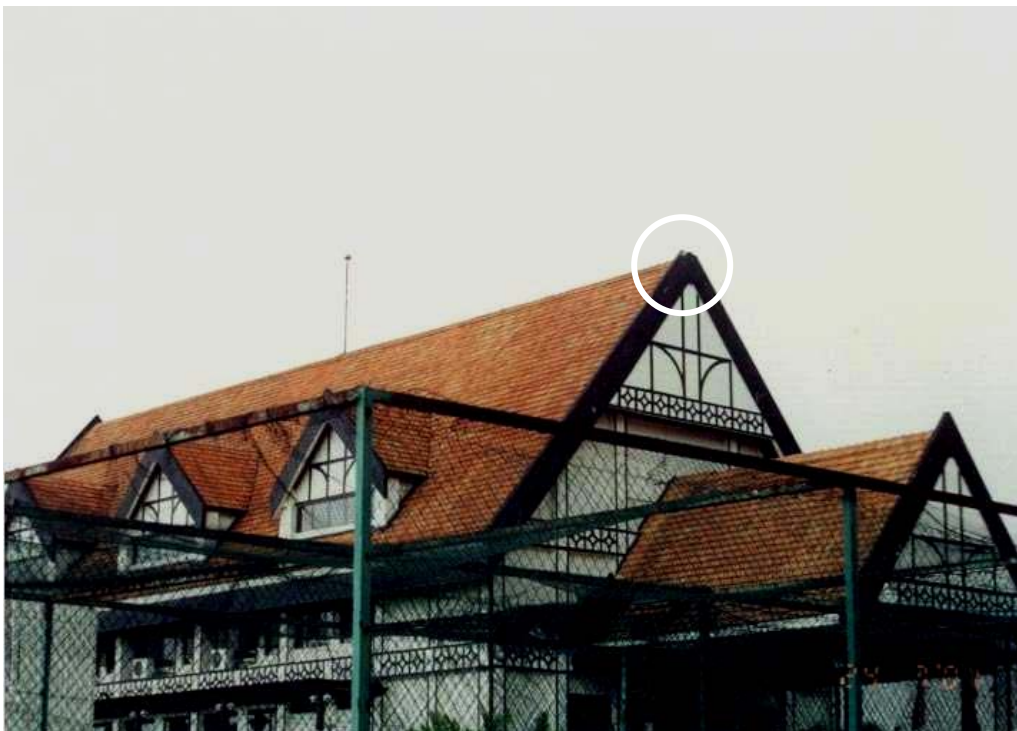
Figure 9: The bypass on the front façade observed in May 2001.

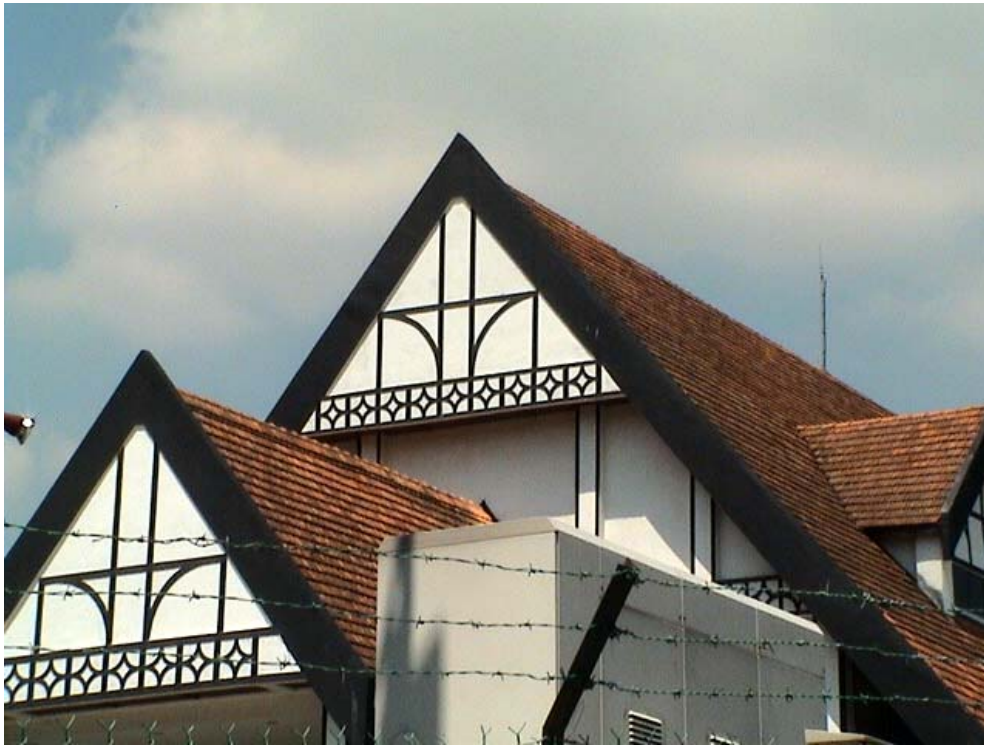
Figure 10: The repaired façade and the new Spanish made ESE air terminal in 2004.

In 2004, the RSC building underwent a major renovation and the damaged façade was repaired. The Dynasphere air terminal was also replaced with a Spanish made ESE air terminal (Fig. 10). A bypass was observed again on the repaired façade a year later (Fig. 11). The three bypasses again cast doubts on the validity of the CVM and the ESE standard as an air terminal placement method (Fig. 12).

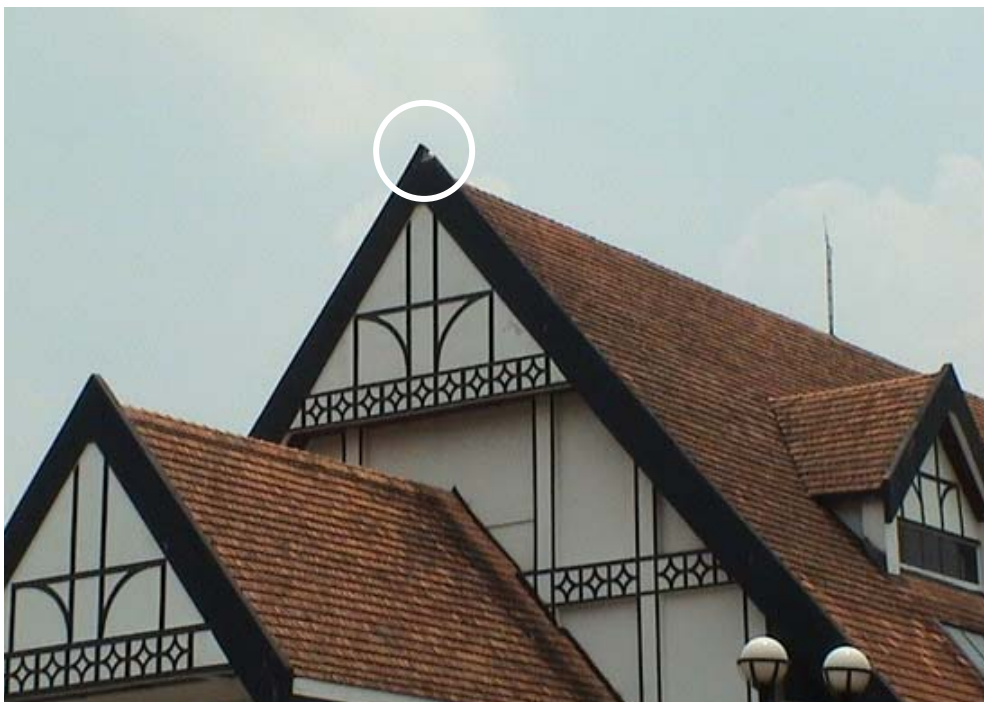
Figure 11: In 2005, another bypass was observed at the same front facade.

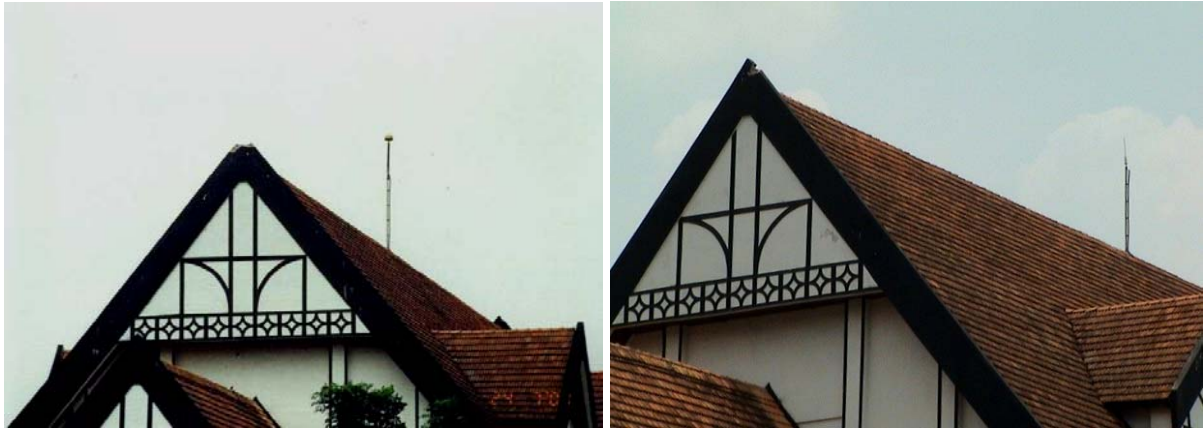
Figure 12: The bypasses at the RSC building suggest that neither the CVM nor the ESE standard, NF C 17-102, is a valid air terminal placement method.

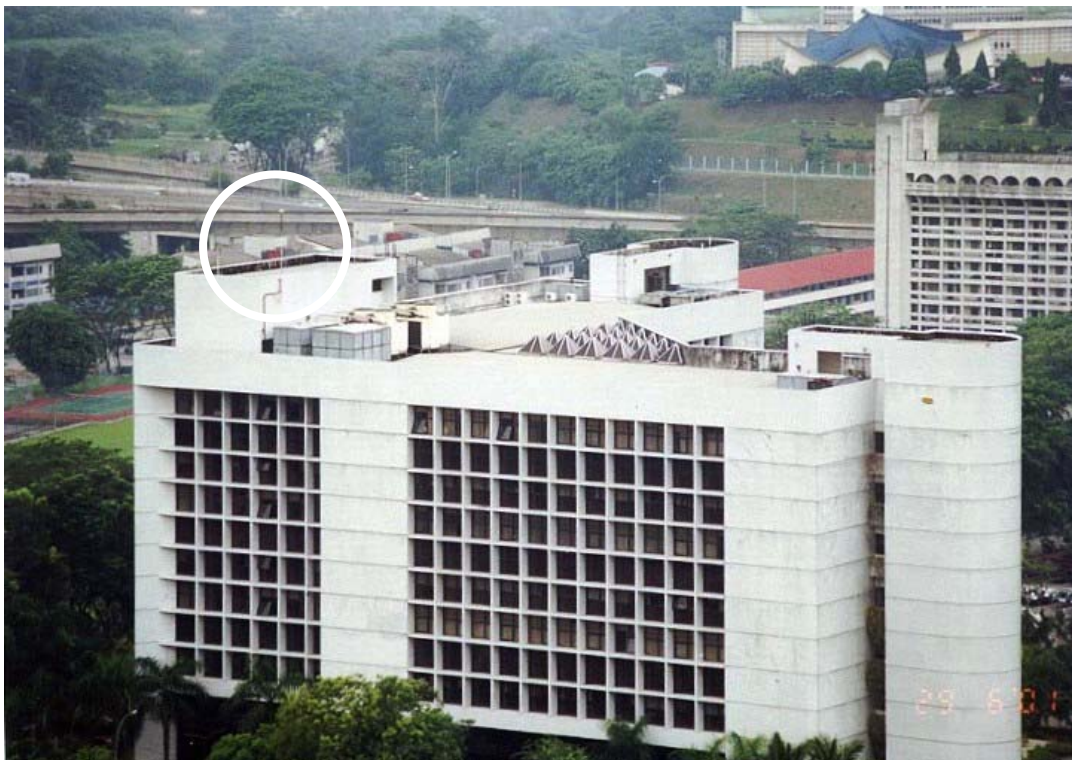
The 30 metre high L-shaped DSC building was installed with the Dynasphere air terminal in 1994. The building, owned by the power utility company Tenaga Nasional Berhad (TNB), is located on a hillside of the Pantai Valley (Fig. 12).

Figure 12: The DCS building photographed from another building which is located to the North-West. The Dynasphere air terminal (circled) was installed at the centre of the building.

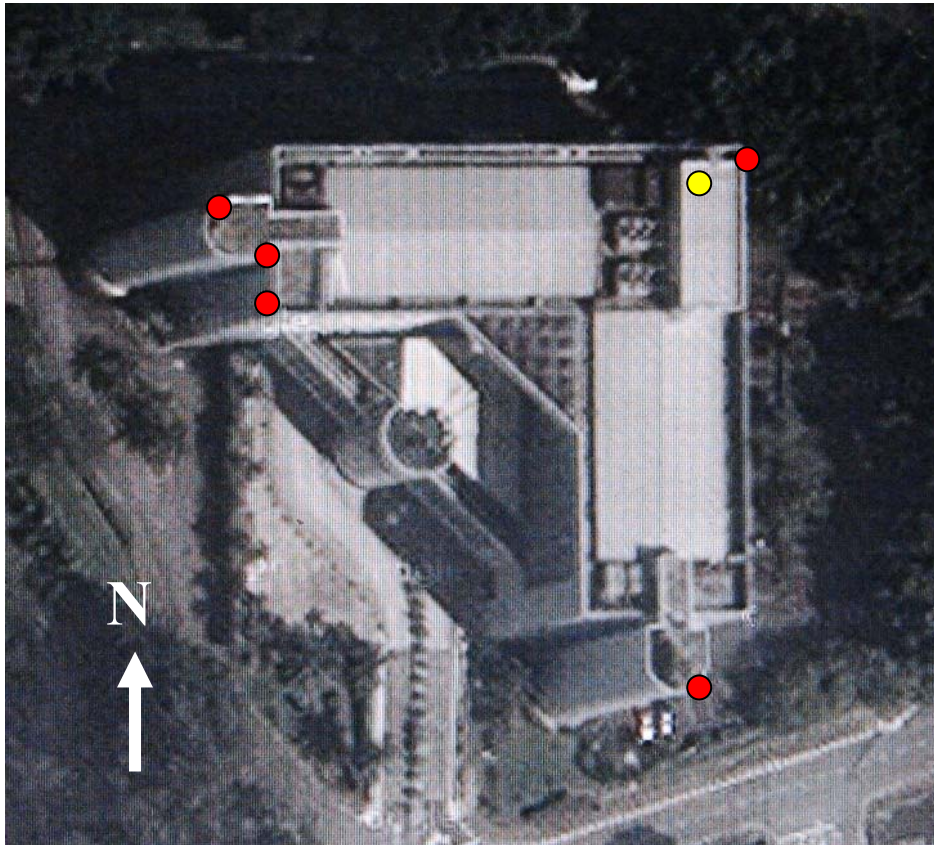
At least five (5) bypasses have been observed and recorded in the last 16 years with one of the bypass located about 10 metres away from the Dynasphere air terminal. Two bypasses were observed on the curved edge of the parapet walls which is supposed to have a negligible or no collection volume according to the CVM hypothesis (Figs. 13 to 16).

Figure 13: The location of the bypasses (red dots) and the Dynasphere air terminal (yellow dot) on the rooftop of the DCS building. (Photo: Google Maps/satellite view)

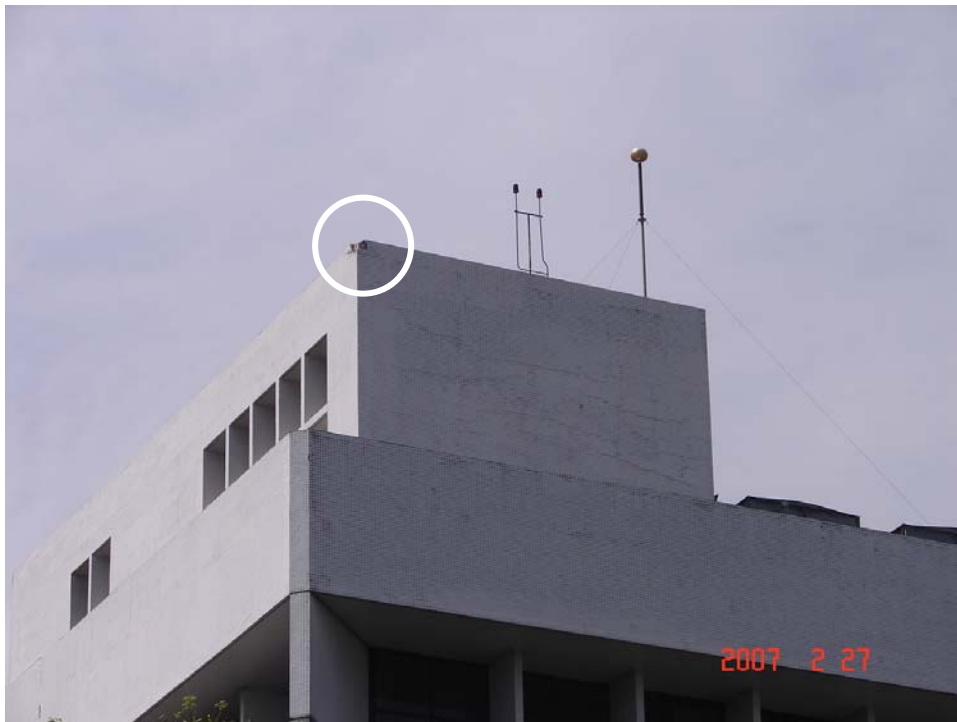
Figure 14: The bypass nearest to the Dynasphere air terminal about 10 metres away.

The proximity of the bypass closest to the Dynasphere air terminal again cast serious doubt on the existence of the so-called “collection volume”.

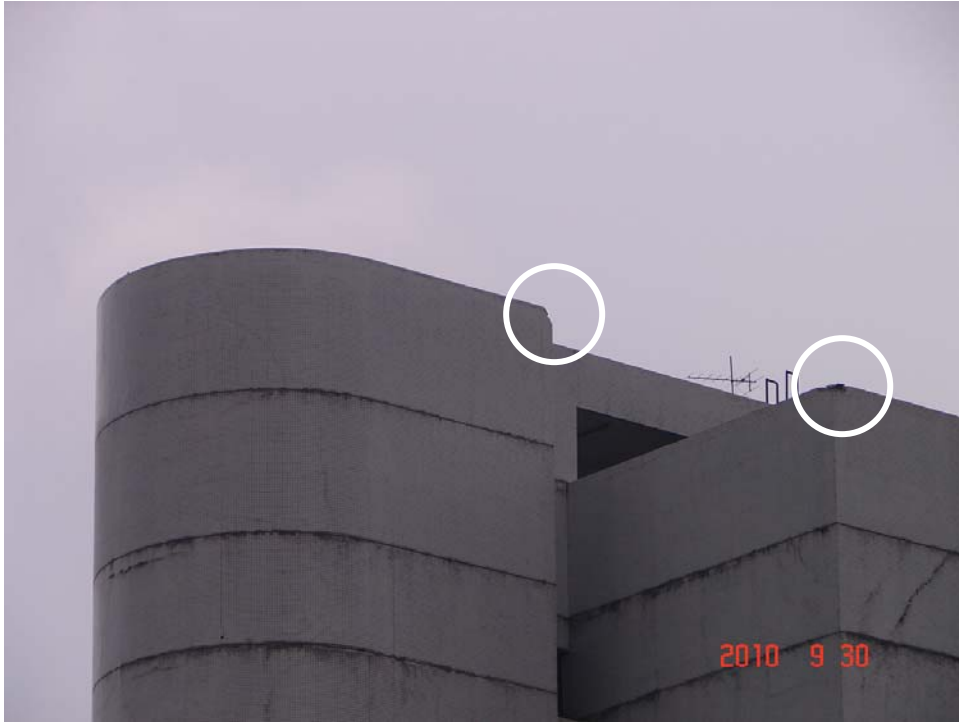
Figure 15: The two bypasses on the west wing of the DCS building.

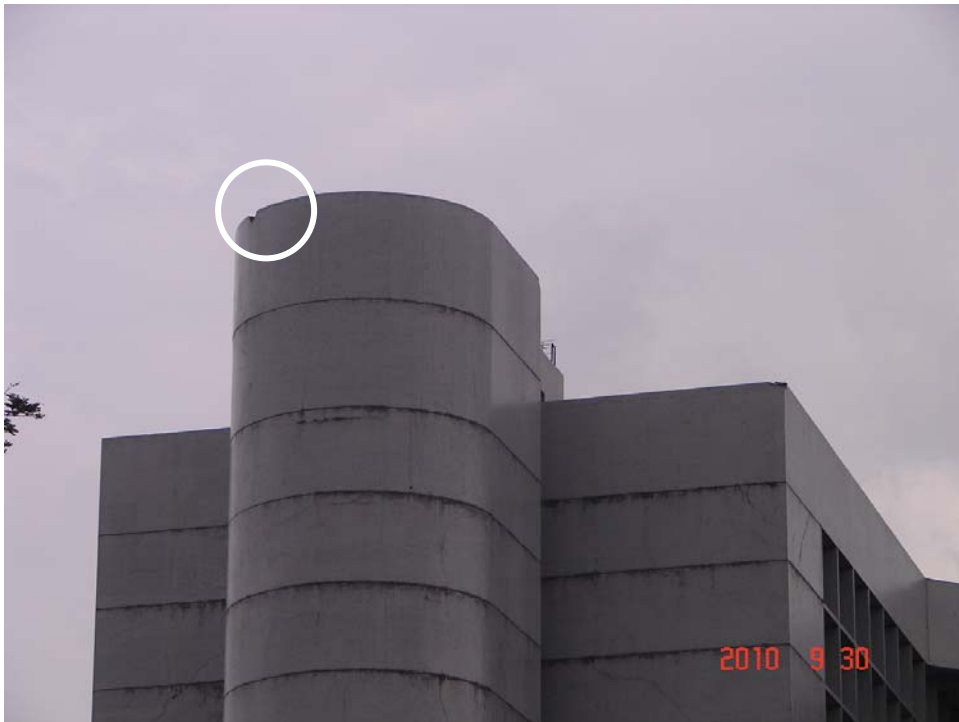
Figure 16: A bypass on the curved edge of the parapet wall on the west wing of the DCS building.

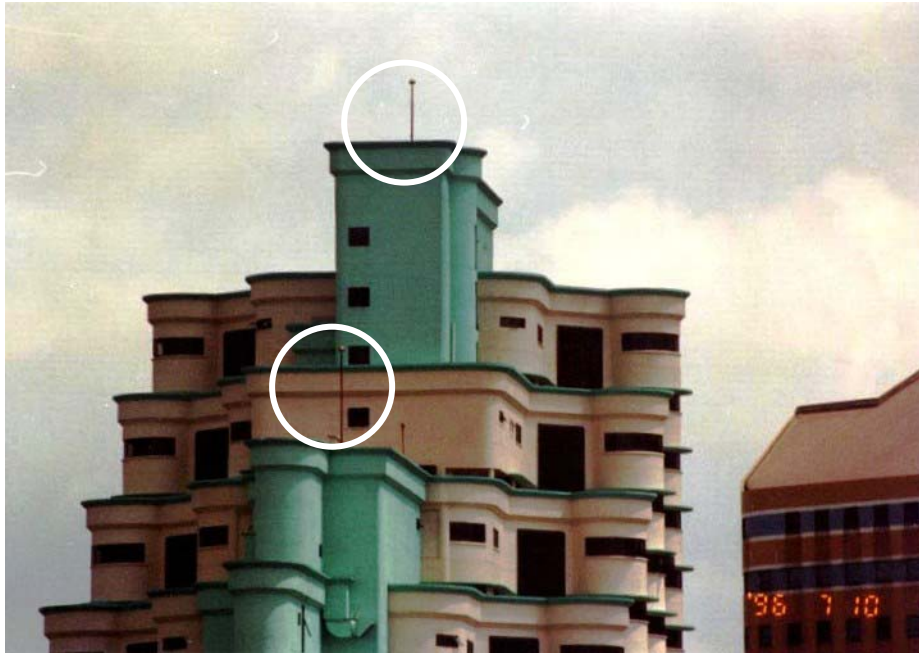
This 170 metre high building was installed with two Dynasphere air terminals in 1996 (Fig. 17). The unique feature of this building is that most of the corners are curved instead of angular thus giving the two Dynasphere air terminals the maximum opportunity to collect all lightning strikes that come within their claimed enhanced “collection volumes”. However, several bypasses have been observed on the curved corners which are not supposed to have any collection volume, thus dispelling the CVM hypothesis (Figs. 18 to 20).

Figure 17: A photo of the Villaputri building and the two Dynasphere air terminals (circled) taken from a nearby tall building in 1996.

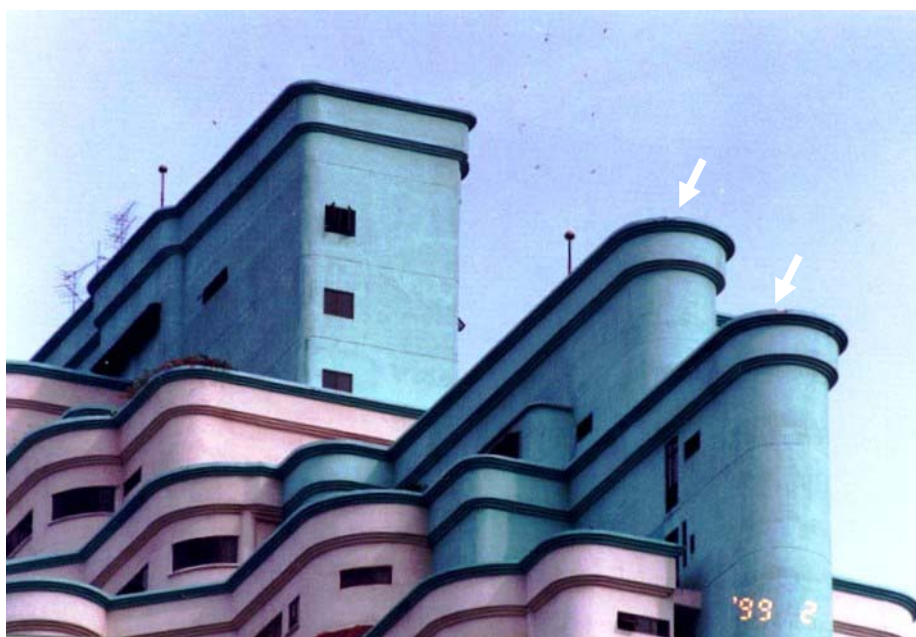
Figure 18: Two bypasses observed on the edges of the middle and lower curved roofs in 1999.

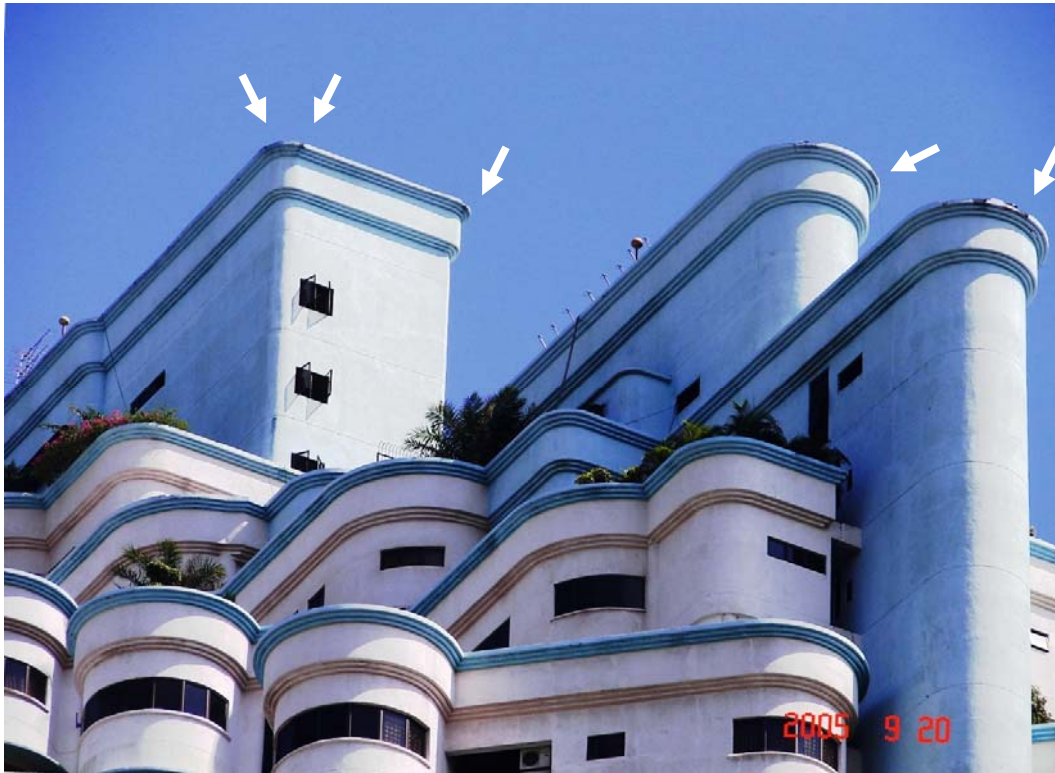
Figure 19: Five additional bypass locations were observed on the edges of the upper, middle and lower curved roofs in 2005.

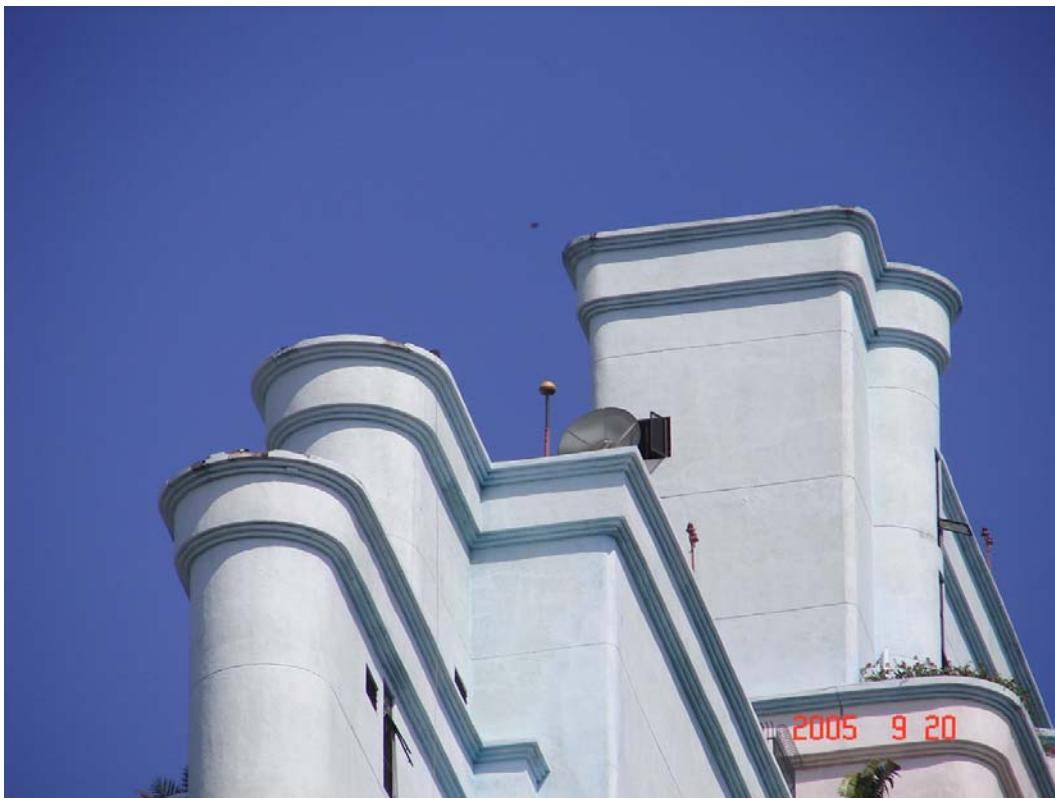
Figure 20: A view of the Villaputri building from a different angle. Since the curved edges had been struck by lightning repeatedly, the claimed existence of the collection volume is doubtful.
