THE BELL TOWER INCIDENT AT SIGOLSHEIM

**A Very Compelling Evidence for the Failure of the
Early Streamer Emission Technology & Standard.**

By
Z. A. Hartono & I Robiah
September 2010
E-mail: zahartono@ieee.org

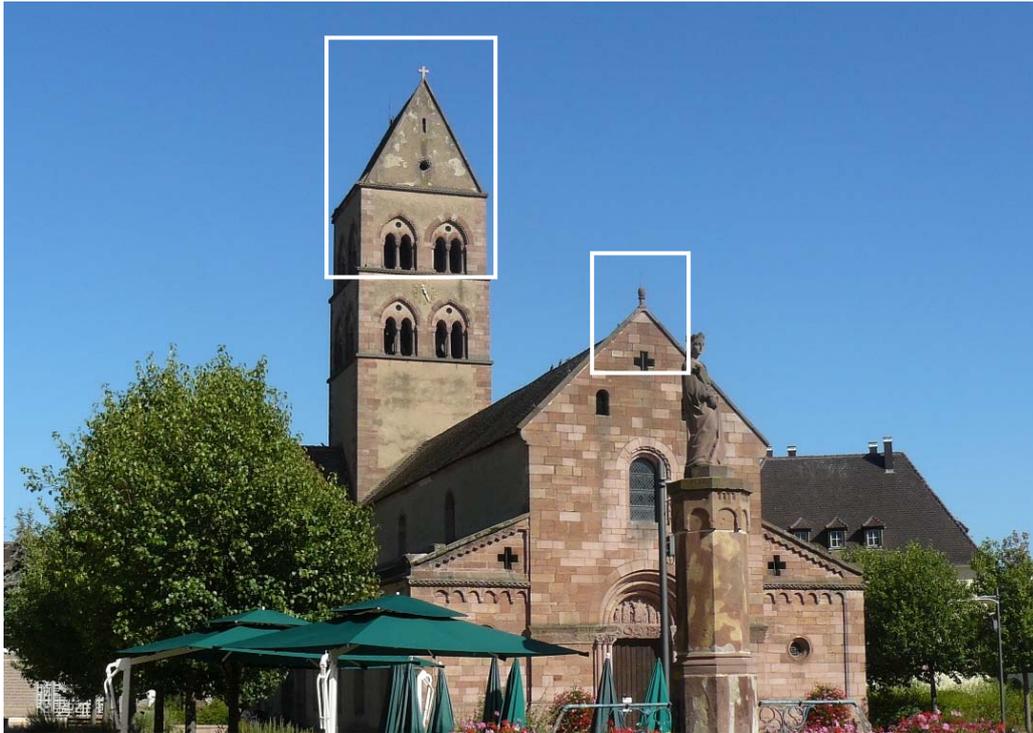
The Saint Pierre and Paul church is a small 12th century church that is located in the town of Sigolsheim, about 300 km east of Paris, near the city of Colmar in eastern France. The annual thunder day (TD) level in this region is about 20. It has a bell tower with a stone cross installed at the front ridge end of the roof. On the rear end of the roof, a Helita Pulsar 25 ESE air terminal had been installed.

Figure 1: The Saint Pierre and Paul church in Sigolsheim. (Photo: Wikimedia)
