## **Conventional and Un-conventional Lightning Air Terminals: An Overview**

### **Synopsis**

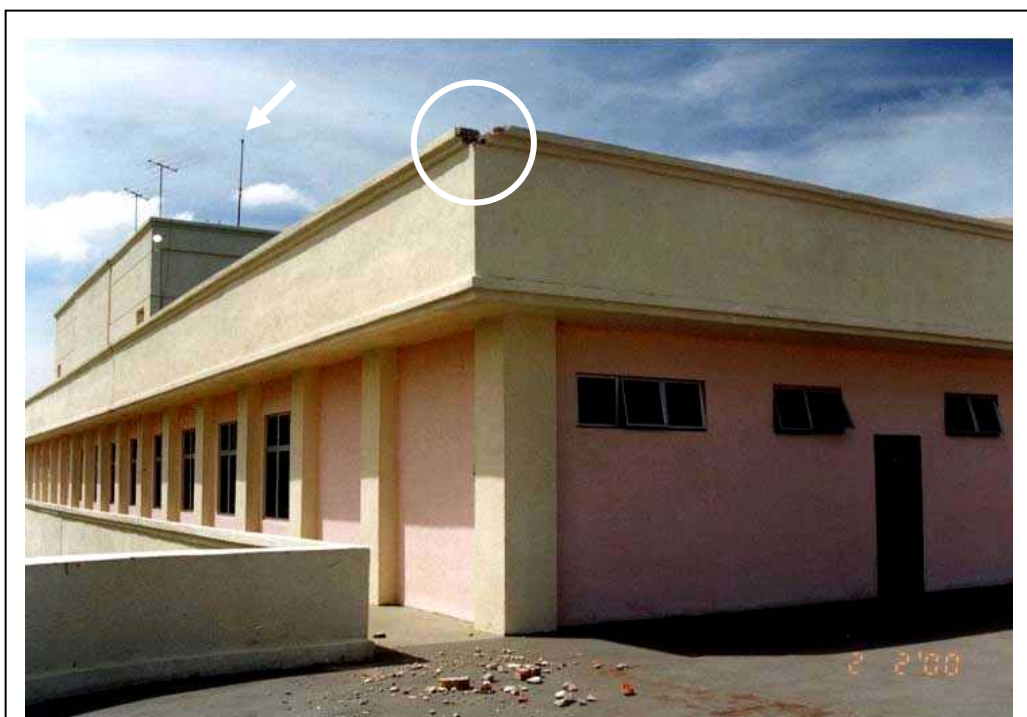
The above picture shows the damaged concrete roof corner (circled) caused by a direct lightning strike. This college building was installed with an unconventional air terminal (arrowed). Debris from such damages is a hazard to people and cars who may be loitering just below the corner at the time of the incident. More than 80% of buildings in Kuala Lumpur that have been installed with the un-conventional air terminals have at least one of this lightning strike damage features on them.

Since the un-conventional air terminal is only installed at the centre of the roof, the edges of the roof are regarded as unprotected. Hence the damage is usually severe when lightning struck these parts.

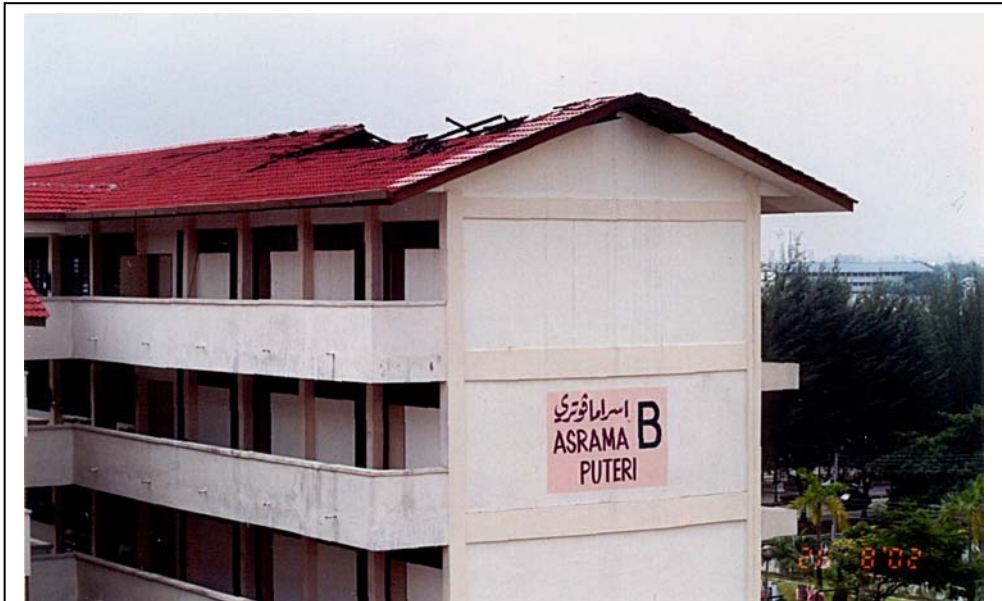
An external view of the lightning damaged hostel of the religious school in Subang Jaya. If the lightning had struck on an occupied dormitory room a few hours later, the possibility of injuries (and even deaths) among the students could not be avoided.

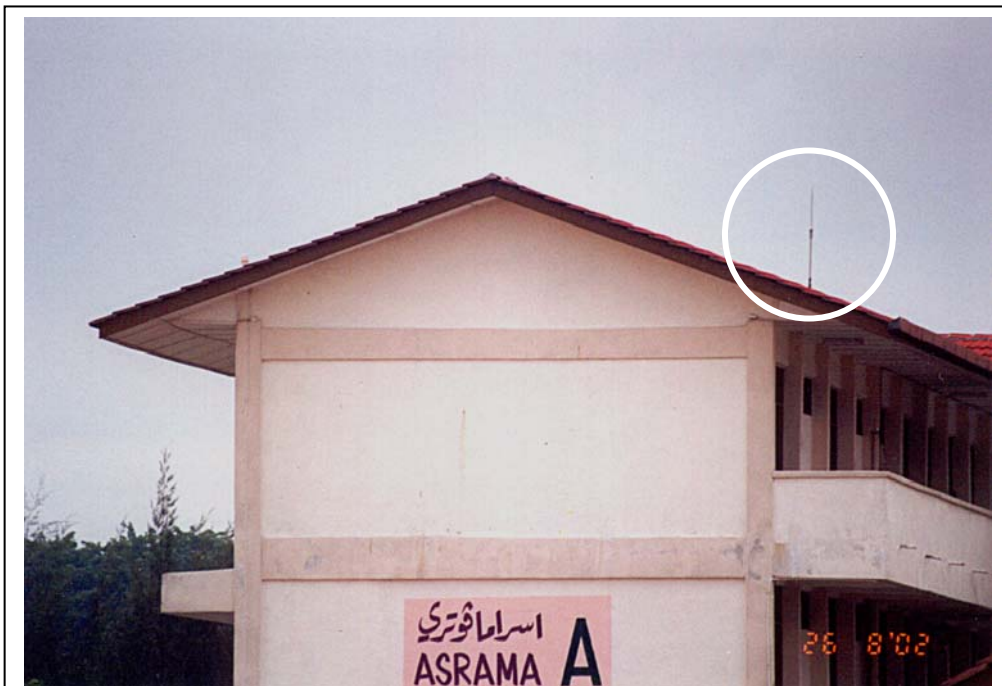
A French-made ESE air terminal (circled) was installed on the roof of the adjacent building (Asrama A) which is about 20m from the lightning strike damage. According to the vendor's product description, this device provides coverage of about 50m radius i.e. to "protect" both blocks A and B. This failure is just another example that the sophisticated lightning protection system does not work.

The Subang Jaya school complex of about half a dozen buildings was installed with three lightning attracting air terminals that is claimed to have protection coverage of about 50 m

each. The lightning strike and resultant fire shows a serious breach of safety had occurred which have a potential to cause injury and loss of life.

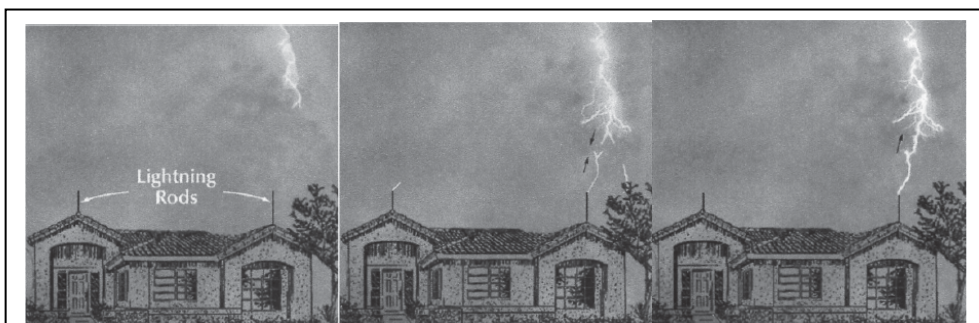
Graphic shows (1) downward leader descending from cloud (left picture); (2) upward streamers emerging from lightning rods and tree (middle picture); and (3) leader-streamer connection (right picture).

The lightning bolt starts initially with another phenomenon known as a downward leader, an current electrical discharge that moves down from the thundercloud. As the downward leader nears the surface of the earth, it increases the electric field in the immediate area below it and this cause the emergence of upward streamers from various objects on the earth's surface (eg. lightning rods, trees, buildings, TV antennae, people etc.).

One of these upward streamers will make a connection with the downward leader and a resultant high current lightning bolt will occur along the connected leader-streamer path.

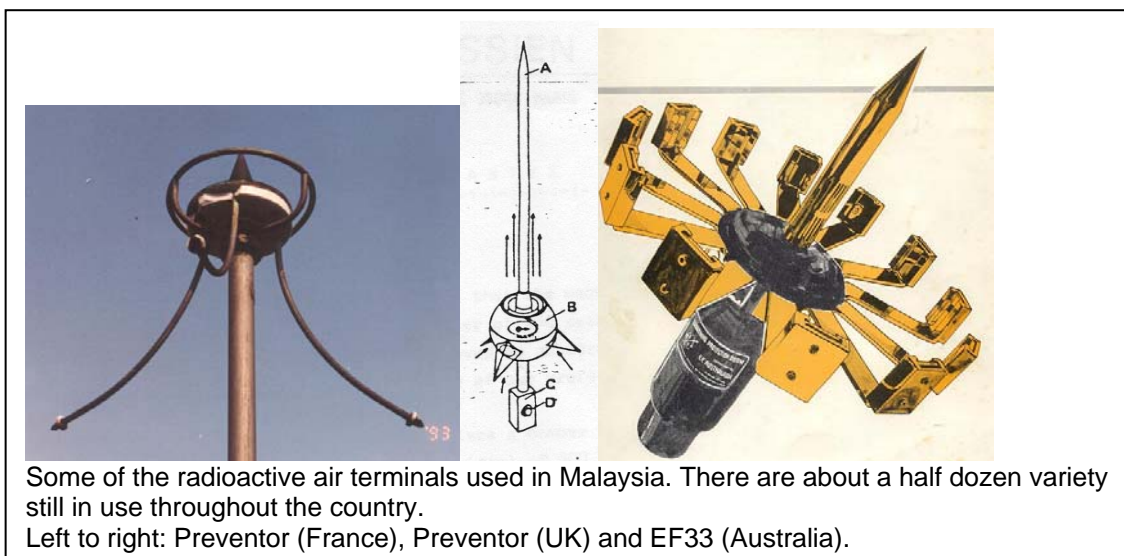
In Malaysia, the radioactive air terminal was introduced in the 1970s and its import and sale was banned in 1989. However, the use of the radioactive air terminal was still allowed by the government if the user obtained a license from the proper authority. Until today, hundreds of these radioactive air terminals can still be found on many buildings throughout the country and some of them have been replaced by the ESE air terminal.

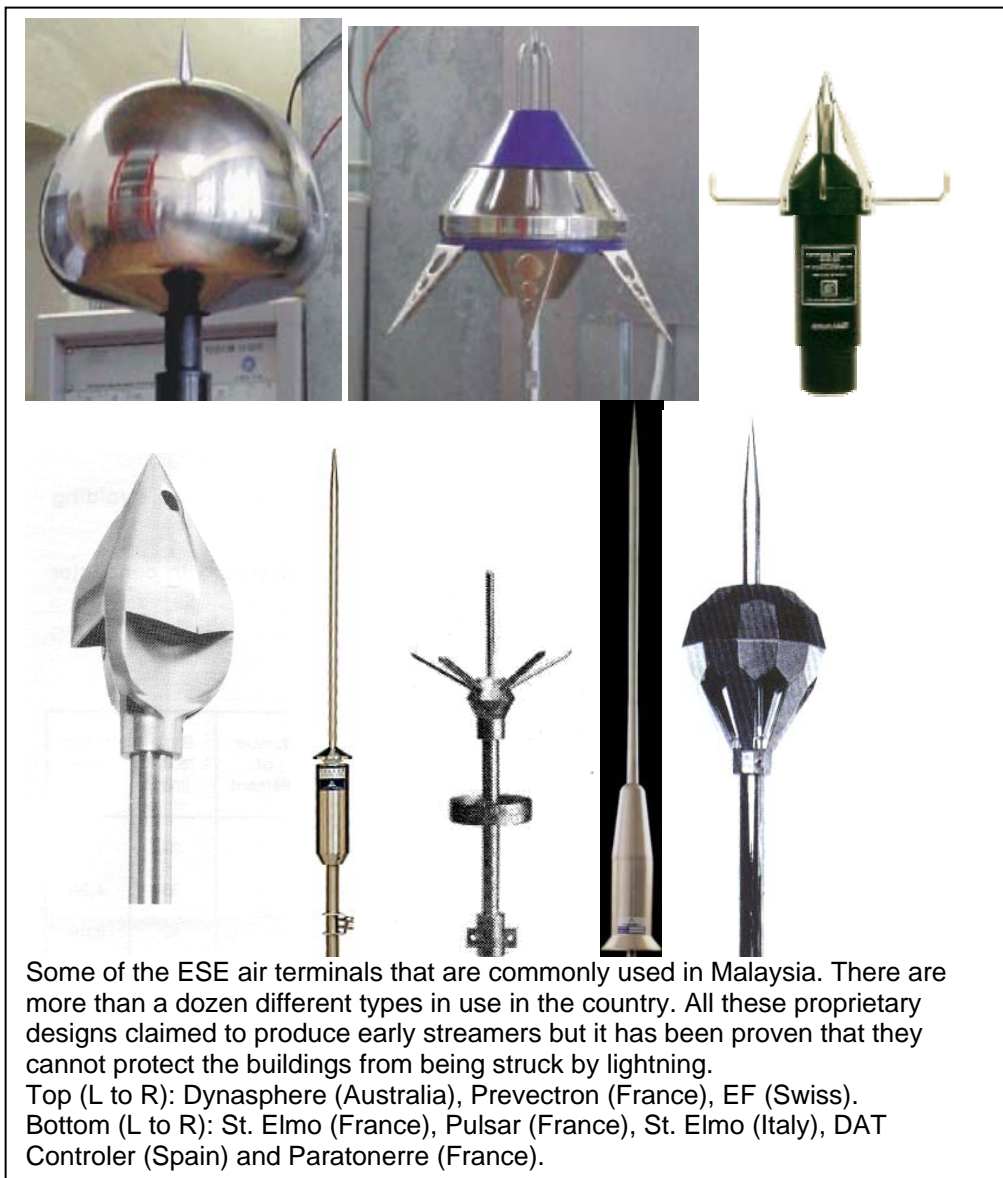
Several independent scientific studies have shown that the ESE air terminals failed to capture lightning in the laboratories. They also failed to capture natural lightning when tested<sup>6</sup> at the mountain top research laboratory in New Mexico, USA. In Malaysia, our

photographic studies<sup>7</sup> have shown that the ESE air terminals failed to protect many buildings from being struck by lightning.

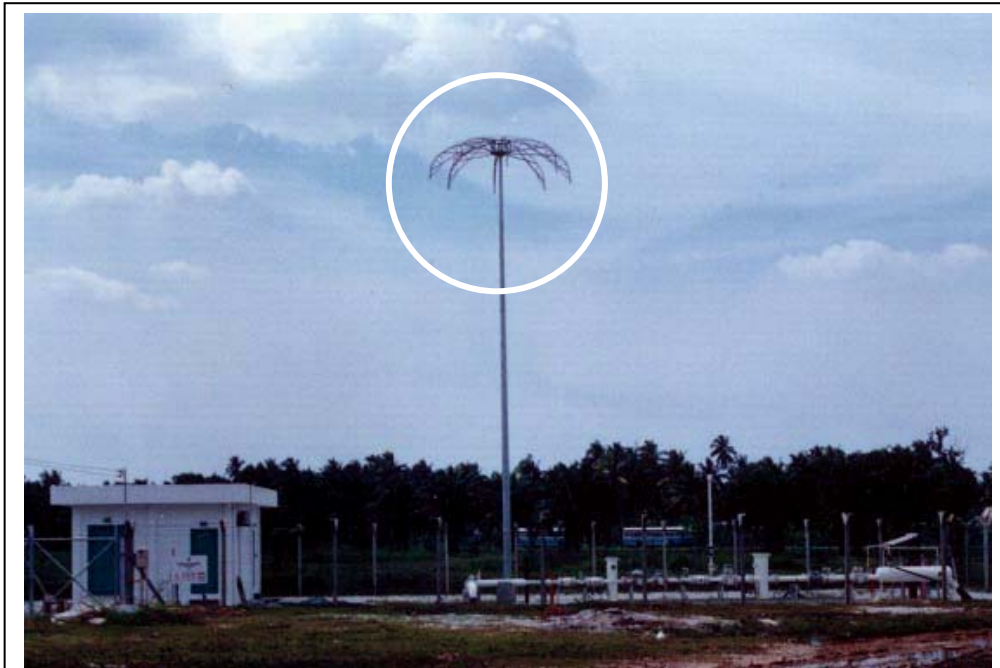
A DAS air terminal (circled) installed at a petroleum gas pumping station in Kapar. Similar installations in the USA have been struck by lightning and have been reported in several scientific papers.

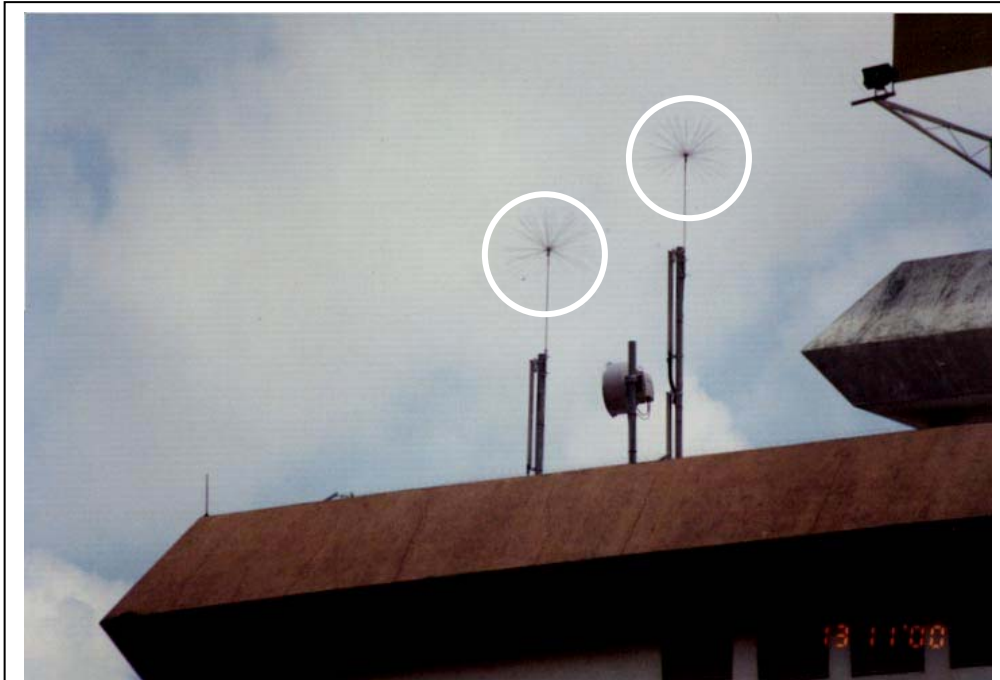
Two Spline Ball CTS air terminals (circled) installed on a telephone exchange in Kuala Lumpur. The failure of these terminals have also been reported in scientific papers.

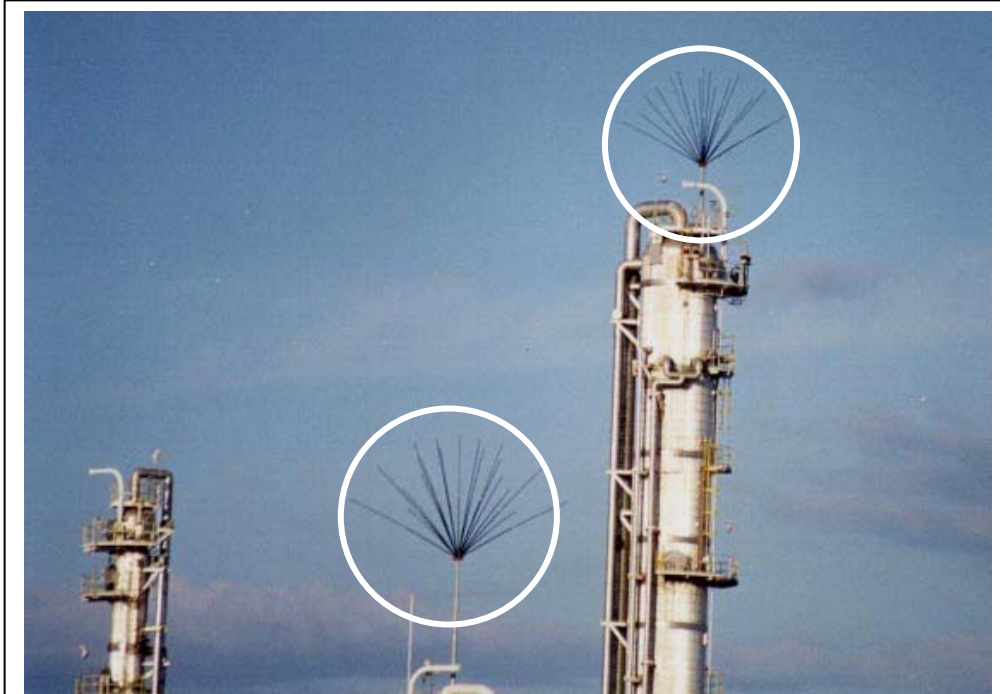
SLE air terminals (circled) installed on petrochemical processing plants in Trengganu. Their claimed ability to reduce the captured lightning current by 99% has been disproved by scientists from the Chinese Academy of Sciences.

Furthermore, a very recent study<sup>12</sup> by two scientists from the Chinese Academy of Sciences show that the lightning reduction properties of the SLE have not been observed when exposed to rocket triggered lightning.

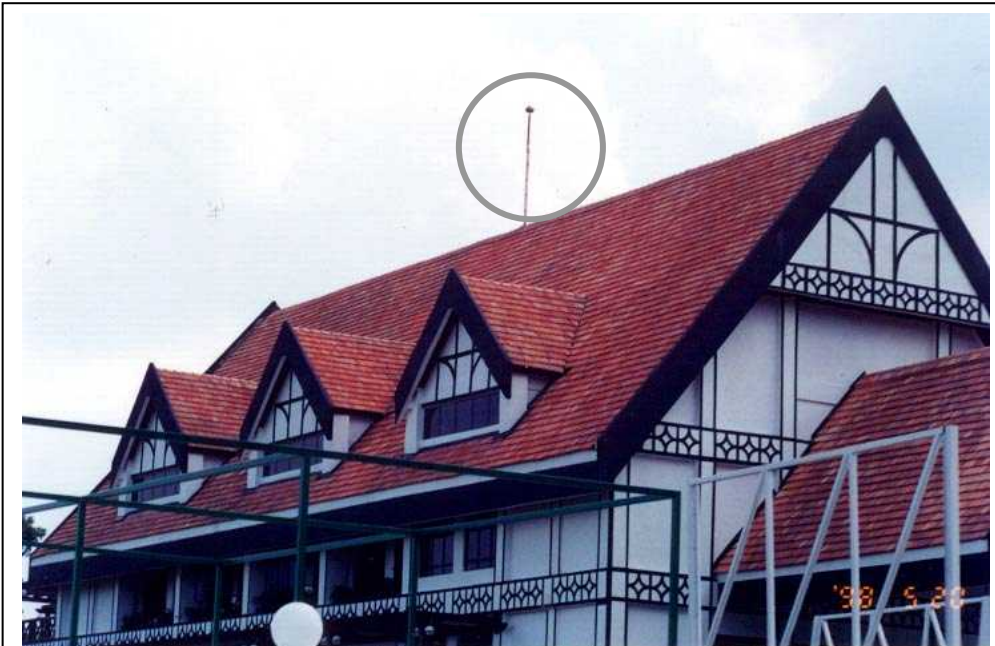
This is an example of a recent “before” and “after” lightning strike photograph. The Royal Selangor Club building in Damasara in 1998 soon after it was installed with an ESE air terminal (circled).

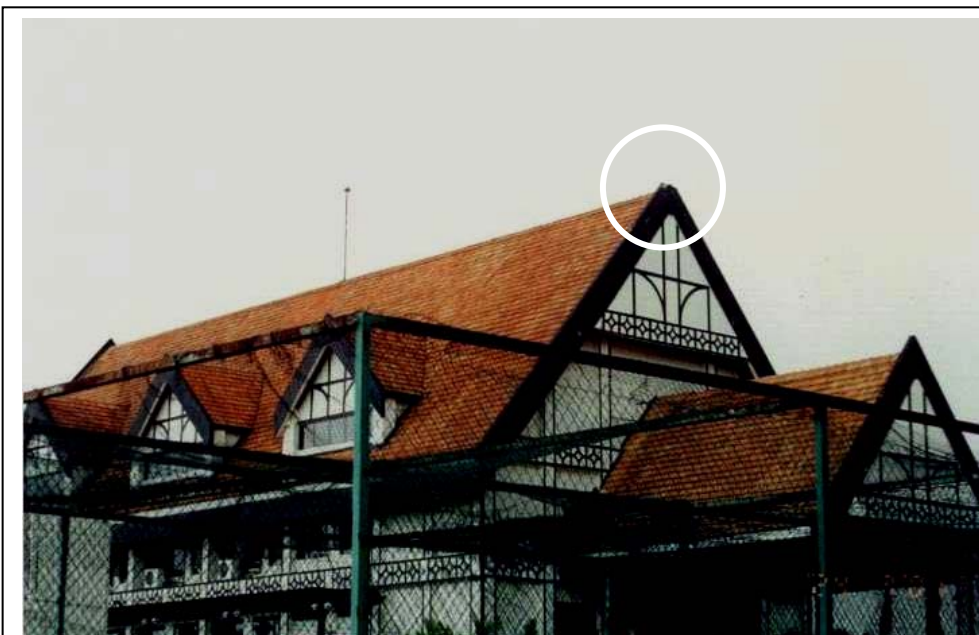
The Royal Selangor Club building after it was struck and damaged (circled) by lightning in 2001. This kind of “before” and “after” photographs have provided indisputable proof to the western scientific world that the ESE air terminals are non-scientific and unproven. We have provided dozens of such examples to western scientists since 1995.

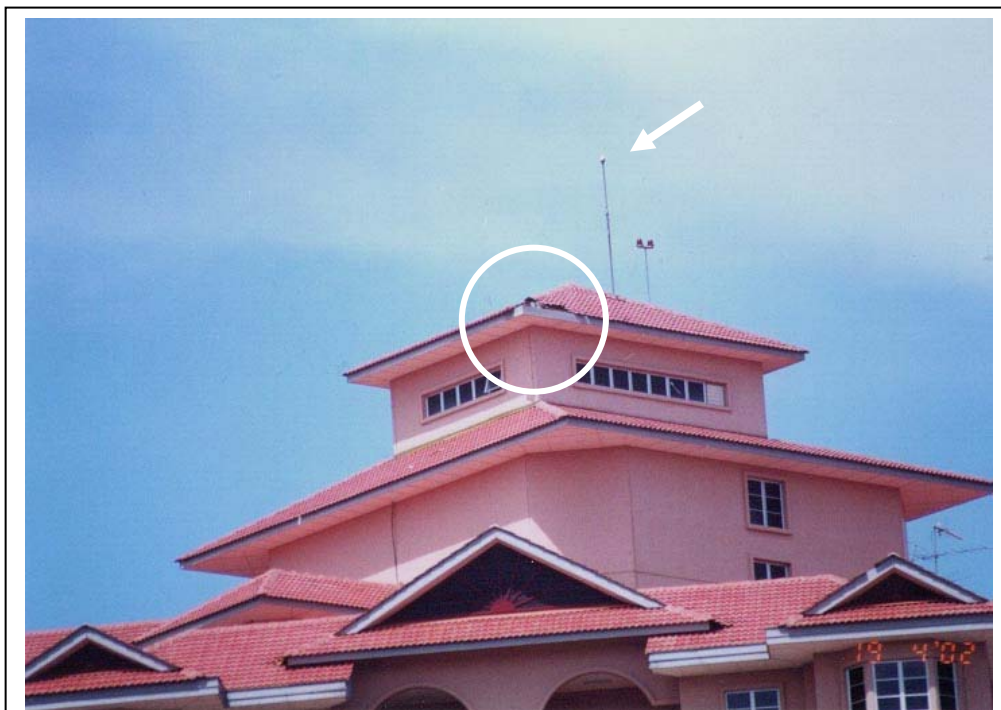
An example of a French made ESE air terminal (arrowed) that was installed on the roof of an apartment in Putrajaya. Although the ESE vendor claimed that this air terminal can provide protection coverage for the entire apartment block, lightning had struck and damaged the roof (circled) just below the terminal. The French authorities are very concerned that French products had endangered the public within and outside their country. Perhaps the Malaysian authorities should do the same since this kind of endangerment occurs within their own country.

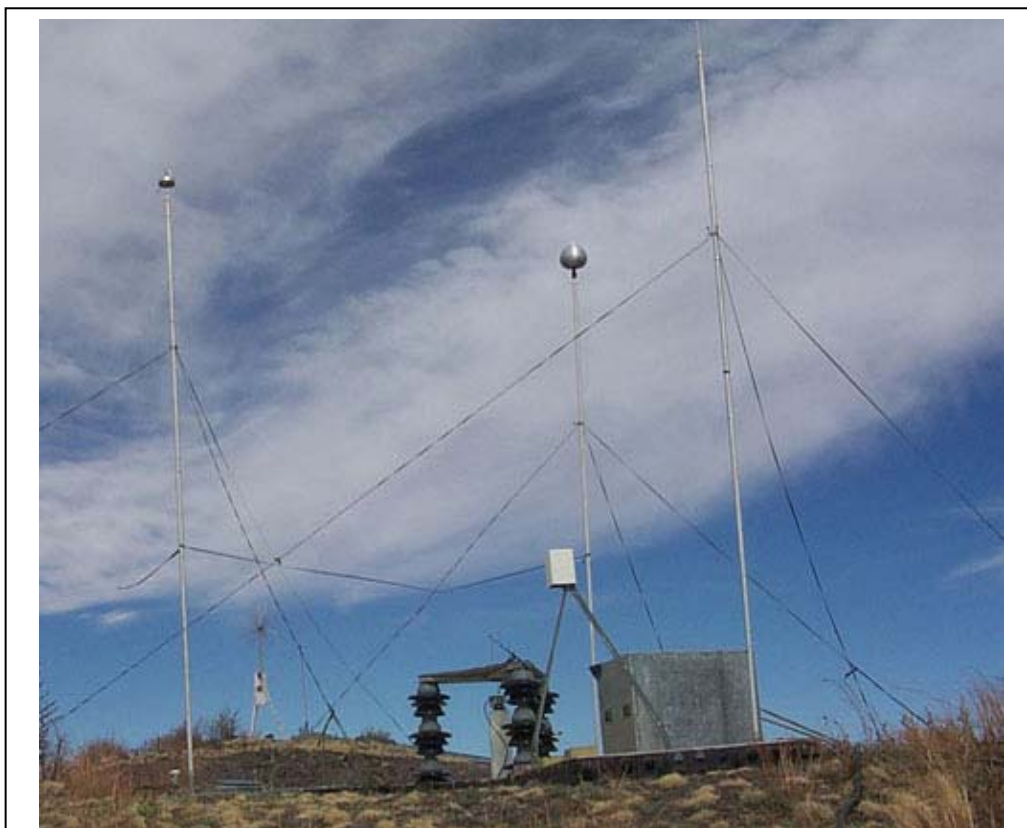
This picture shows of one of the New Mexico test sites where several types of ESE (French and Australian air terminals) and conventional air terminals had been exposed to lightning for several years to gauge their effectiveness under natural lightning conditions.

thunderstorms at the mountain top testing ground. Only the blunt tipped Franklin rods, which were also installed as part of the experiment, were struck several times while none of the ESE air terminals and the sharp tipped Franklin rods were struck.

This independent study suggests that the ESE air terminals tested did not have the ability to attract lightning as claimed by their manufacturers. However, the ESE sales engineer would ignore all their earlier studies and refer only to the “on-going research” in order to dupe the unsuspecting customer.

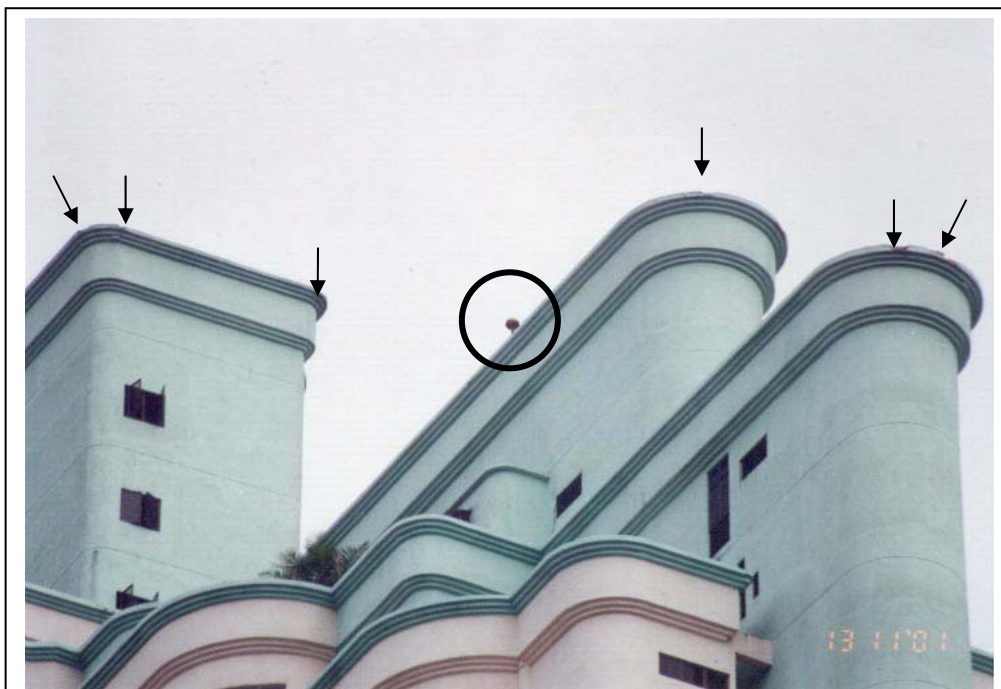
The Villa Putri apartment building in Kuala Lumpur was damaged (arrowed) by lightning at 7 different places on the roof. In spite of this building being a subject in a conference paper in 2000, the sales engineer still informed the building manager in 2002 that the building was free from lightning strike damages. One of the two Australian ESE air terminals can be seen above (circled).

However, the sales engineer had succeeded in assuring the customer that the damages were nothing more than building defects and that the ESE air terminals were functioning normally. In 2002, the customer was still receiving reports from the ESE vendor that indicated no bypasses had occurred.

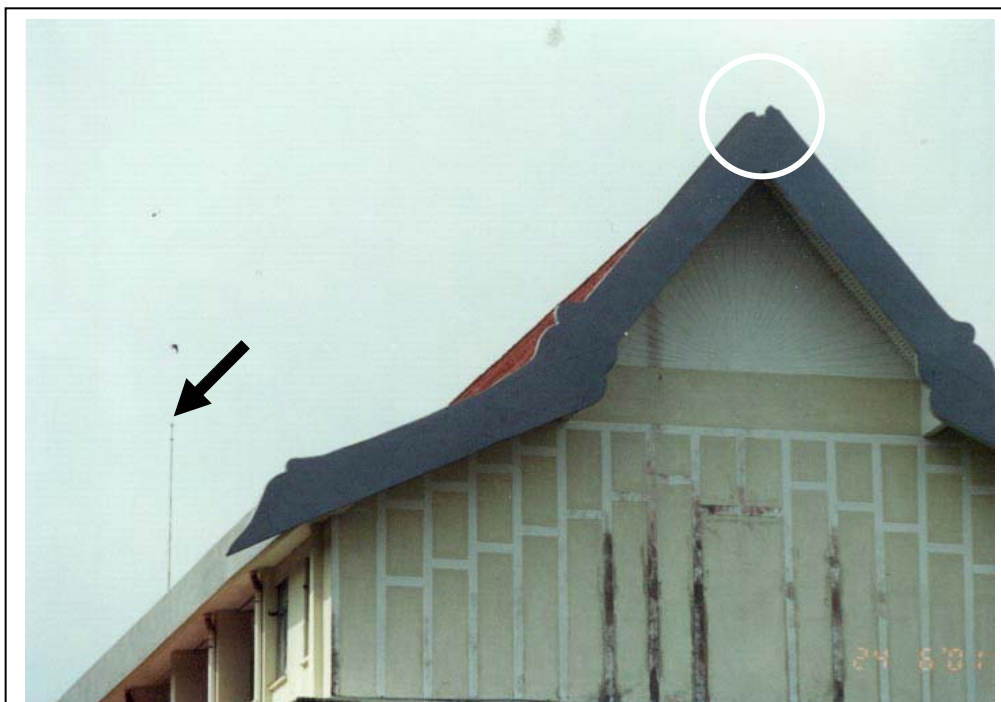
One of the UTM buildings in Skudai that had its façade damaged (circled) by lightning. An undamaged façade would have a sharp pointed apex. Several other similar buildings had been struck also with the damage in varying sizes. Most of the faculty buildings were installed with the ESE air terminals (arrowed).

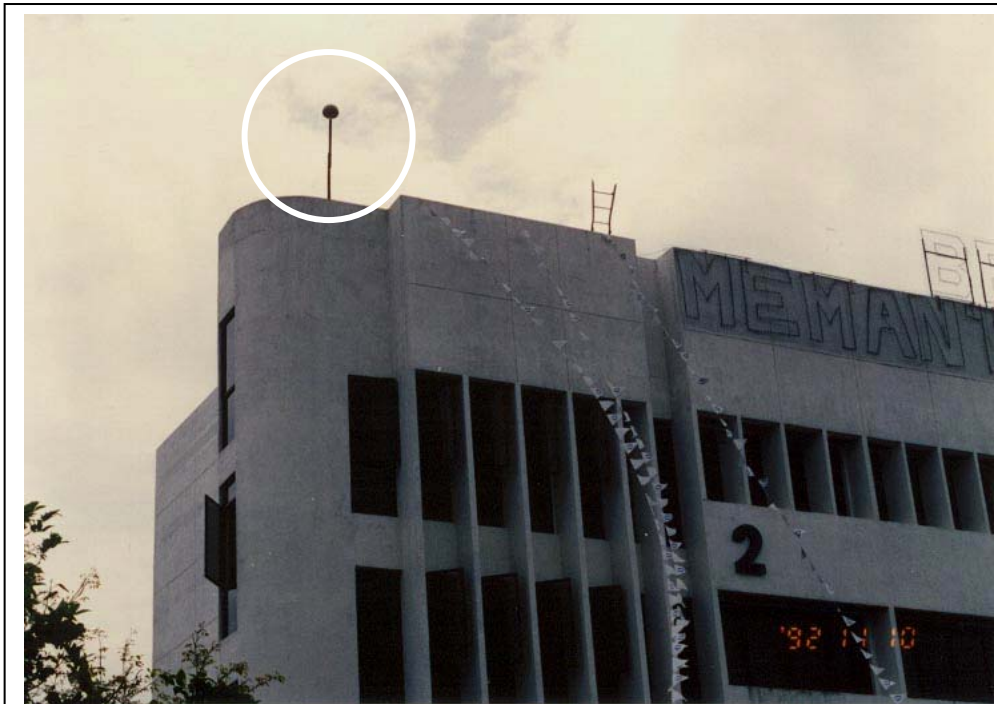
An ESE air terminal (circled) installed on Building #2 of the SIRIM complex in 1992. Another type of ESE air terminal had also been installed on Building #3.

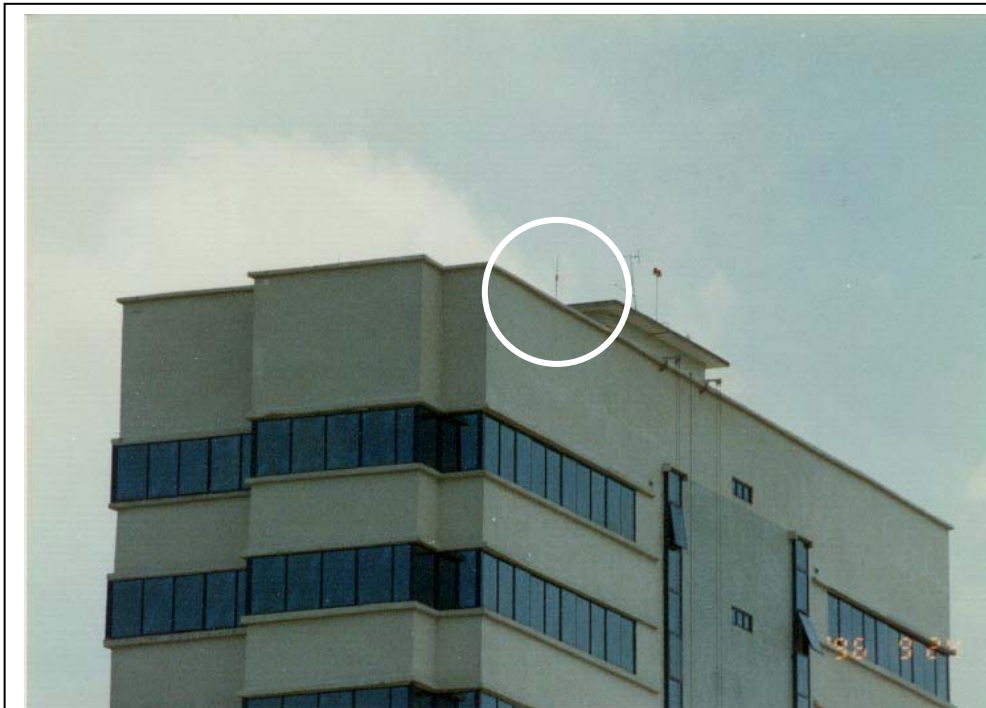
Another type of ESE air terminal (circled) installed on the new SIRIM head office building in 1996 i.e. nearly a year after the ESE had been rejected by the IEC. This building was struck and slightly damaged by lightning not long after this picture was taken.

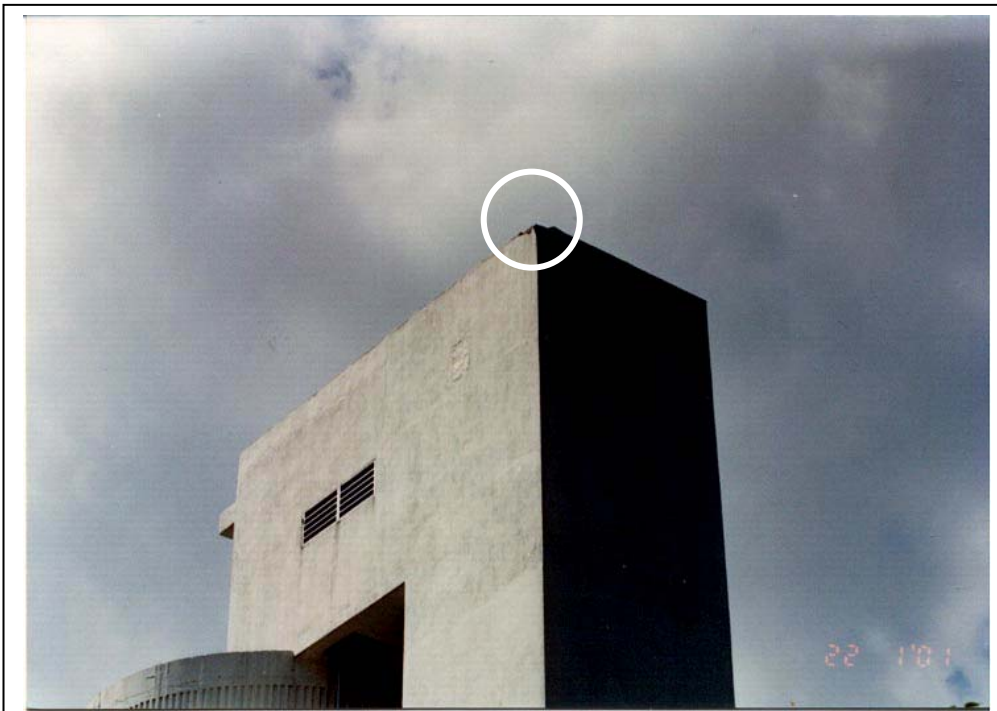
The SIRIM Block #8 without the ESE air terminal in January 2001. The building had sustained lightning strike damage (circled) in 1999.

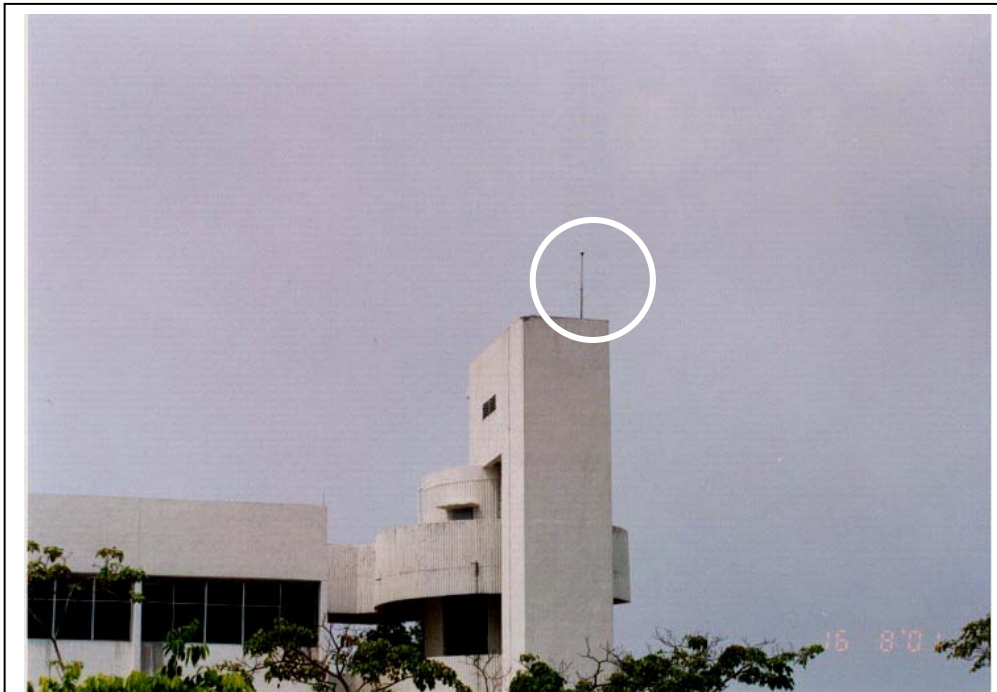
The SIRIM Block #8 with the ESE air terminal (circled) that was installed between January and August 2001. SIRIM still continued to install the ESE air terminals even though the ESE technology had just been dropped from the new Malaysian standard.
